CIGRE US National Committee 2016 Grid of the Future Symposium

Transformer Saturation Due to Transmission Line Induction

**S. SANKAR
S. SRINIVASAN
Black & Veatch
USA**

**J. PELON
ITC Holdings Corp.
USA**

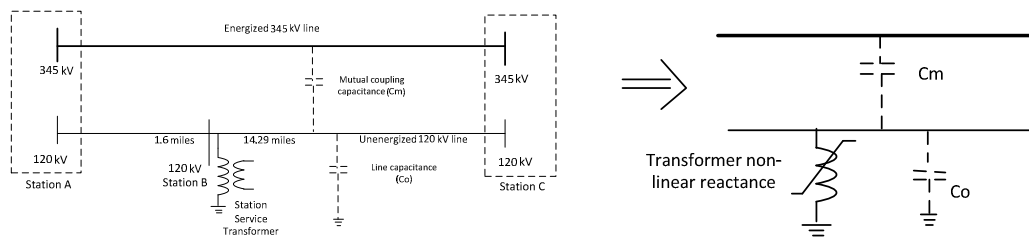
Figure 3 : Mutual Capacitance and Resonant Circuit

The induced voltage due to a parallel energized circuit is usually a fraction of the energized voltage. However, the presence of any inductive elements along the line such as shunt

reactors or transformer magnetizing reactance could introduce resonant conditions. In the case of a transformer, the resonant condition could drive the transformer to saturation, thereby leading to high magnetizing currents. Figure 3 illustrates the resonant circuit condition.

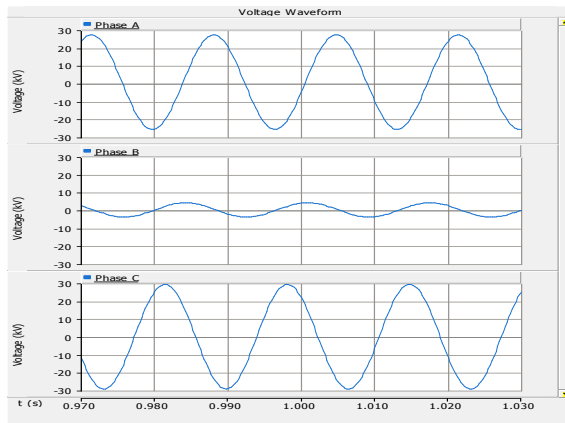
Figure 4(a) : Induced Voltage on the 120 kV line

A study was carried out to evaluate the induced voltage on the parallel unenergized 120 kV line using PSCAD simulation. The 345 kV / 120 kV double circuit between Station A and Station C, and the station service transformer were modelled using their actual design values. The load current on the 345 kV line was set to the value that was observed on the day of the transformer failure. The transformer magnetizing characteristic was modelled based on the factory test reports. Figure 4(a) shows the calculated induced voltage on the 120 kV line due to the energized parallel 345 kV line and Figure 4(b) shows the secondary side voltage of the station service transformer connected to Phase A. It can be noticed from Figure 4(b) that the calculated induced voltage is about the same magnitude as that was observed by the maintenance crew.

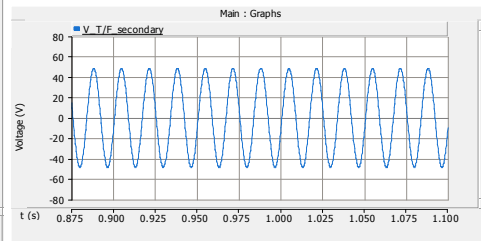
Figure 4(b) : Transformer Secondary Voltage

The transformer primary (magnetizing) current was calculated to be 0.85 mA which was well below the nominal design value of 1.7 mA.

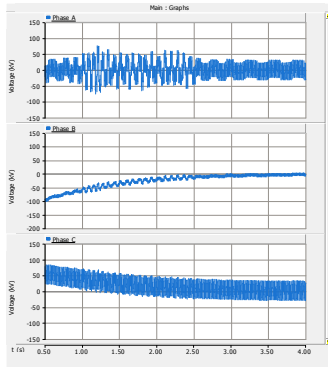
Figure 5(a): With 10% Trapped Charges

It can be noticed from Figure 5(a) that with small amount of trapped charges, the Phase A voltage settles down to a value corresponding to only the induced value pretty quickly. On the other hand, with large amount of trapped charges, a high voltage of as much as 130% is established on Phase A at the time of line disconnection and this voltage is sustained for a prolonged period. Eventually this voltage would settle down to a value just corresponding to the induced voltage value. Due to smaller time step and longer computational time, simulation was halted before the voltage reduced down to just the induced voltage.

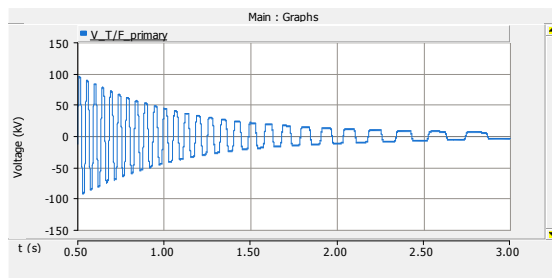
Figure 7(a): Transformer Voltage Without Mutual Coupling

A simulation was also carried out to illustrate the impact of the induced voltage by considering just the trapped charges without the mutual coupling with the adjacent circuit. The transformer voltage and current for this scenario are shown in Figures 7(a) and (b),

respectively. It can be noticed that the voltage on the unenergized line was not sustained without the induced voltage.
