CIGRE US National Committee 2016 Grid of the Future Symposium

Partial Discharge Monitoring: Lessons Learned and Consequential Safety Improvements at AEP

R. CORNELL*, K. ZELLERS, B. MEHRABAN, B. JOHNSON American Electric Power (AEP) USA

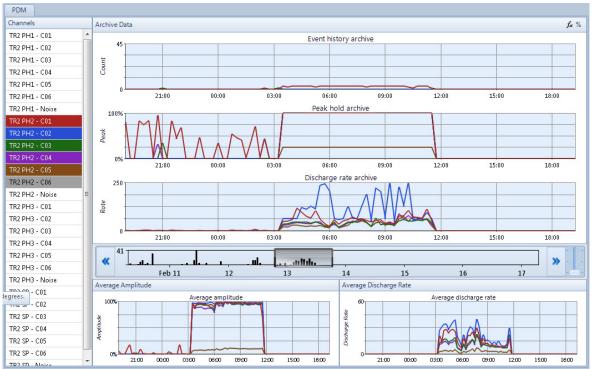
Figure 1: February 2014 Failure Event - UHF Partial Discharge Detection System Data Summary

The UHF system indicated an increase in partial discharge activity on all six sensors with five out of six sensors at a measurement reading of 100% amplitude. This activity continued until the unit failed catastrophically at approximately 11:45 EST. The discharge rate measurement also increased significantly during this time frame. The partial discharge signature seen below in Figure 1, shows that the measurements of the partial discharge were present for about eight hours before the unit failed.

One of the major concerns with this failure was that the area around the transformer was an active construction site at the time of failure. Oil containment was being installed around the single phase units that day. Ten to twenty construction personnel were around the transformer right before the unit failed. Fortunately, the transformer failed at the best time it could have, while everyone was on lunch, away from the unit. If this unit had failed earlier or later on that same day even by a margin of thirty minutes, the resulting explosion of the transformer could have been life-threatening to those working on the site. The root cause analysis of this failure is still on-going. Below is a screen-capture of the pre-catastrophic failure signature collected from the UHF partial discharge sensors.

After the two failures described above, a new alarming scheme was implemented at all sites where the UHF partial discharge system was installed. Rather than relying on any individual sensor, a combination of three sensors, one at or above a magnitude of 95% coupled with two additional sensors with magnitude readings at or above 75% is used to alarm. This three sensor combination signature initiates a "rapid partial discharge alarm" to the Transmission Operations Center who would alert employees to the possibility of catastrophic failure of the transformer or shunt reactor at the substation. All other alarms or warnings due to a single sensor are sent to the Asset Health Center Team for further analysis via email alerts.

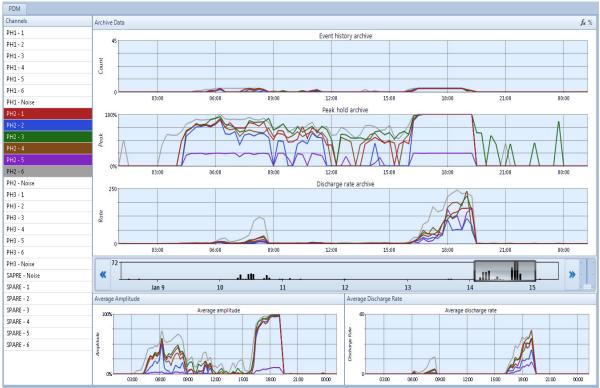
Figure 2: January 2015 Failure Event - UHF Partial Discharge Detection System Data Summary

In January of 2015, AEP experienced a second catastrophic failure of a single phase 765 kV autotransformer. This transformer had been energized and in service for about one year before failing violently. This unit was also fully equipped with the standard set of monitoring equipment including the bushing health monitoring, UHF partial discharge monitor, temperature monitor and dissolved gas monitor. This failure was a much faster acting failure than the February 2014 event, with a timeframe of three hours compared to eight hours, with the activity spiking in the same manner with all six sensors showing increased amplitude and discharge rate with five out of six sensors reaching the 100% peak amplitude measurement as shown in Figure 2 below. The same pre-catastrophic failure signature appeared in this failure as in the February 2014 failure event shown below in Figure 2.

As in the first failure event, the dissolved gas monitoring equipment did not see this failure until after the transformer had tripped out of service. Unfortunately, the failure occurred between the scheduled dissolved gas measurements timeframes, thus not capturing an increase in gas composition until after the unit had failed.
