## **A Tubular Hydro-Generator Through-Bolts Failure Troubleshooting**

**L. JIANFU, Z. GUANGHOU, L. YIGANG, X. JIAN, L. CHUANKUN**  
**DongFang Electrical Machinery Co., Ltd.**  
**China**

### **SUMMARY**

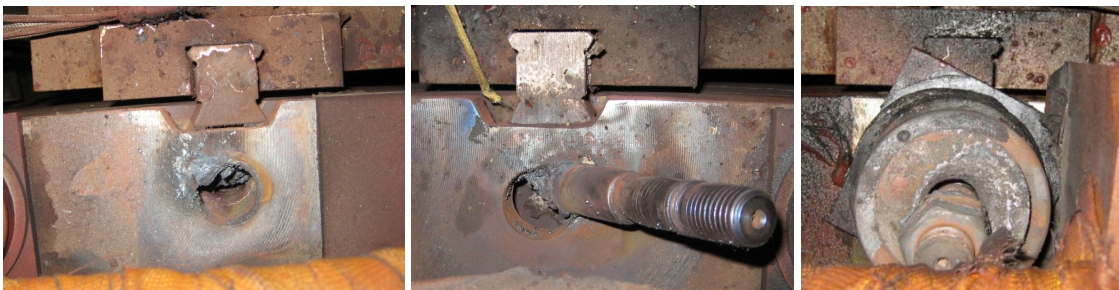
According to the inspection, 32 bolts with insulation failure; 21 bolts with the insulation resistance value zero; eight screws in 132 screw were melted. Phenomena has the following characteristics:

- The melting bolts distribution has obvious pattern as they are opposing the key bars.
- Leaked oil found on bolts.
- Some key bars are over heated.
- Some fracture is transverse fatigue fracture.

Fig 1. Melted through bolts and heated key bar

According to the investigation, it seems large force was applied to the damaged bolts. After years of operation, the fatigue fracture formed. At the meantime, large loss generated in the bolts and the bolts melted. It was likely that after the through bolt insulation damaged, the through bolts were short circuited with the key bars at the back of stator core.

- a) Improve the bolt fixation to avoid 100Hz natural frequency.
- b) Use thicker bolt insulation.
- c) Fill the gap between the core and bolts with flexible material to minimize the vibration.
- d) Improve the seal to reduce the oil mist.
- e) Clean the oil mist regularly.

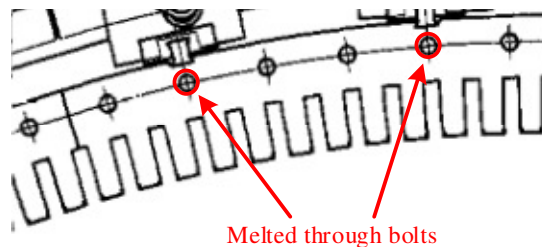
Fig 2. Melted through bolts distribution

- d) The bolts near the key bars are more easily short circuited which the key bars. So they are more likely to melt and broke.

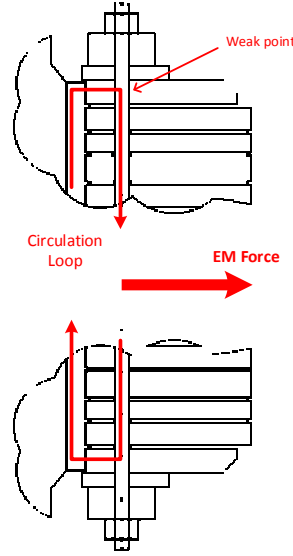
Fig 4. Short circuit path

The most serious condition is that the through bolts are short-circuited at the end parts with key bars and core [2]. And the Electromagnetic field is analyzed.

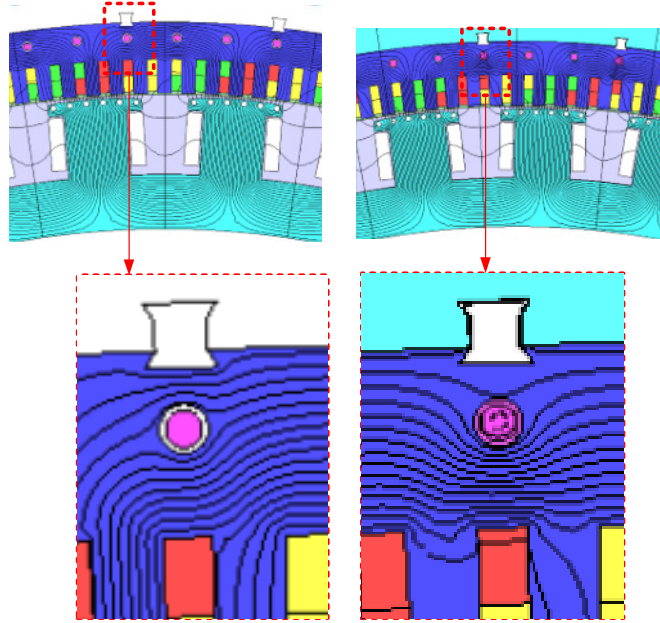
Fig 5. Magnetic flux line distribution at no load condition with insulation in good condition(left) and in bad condition(right)

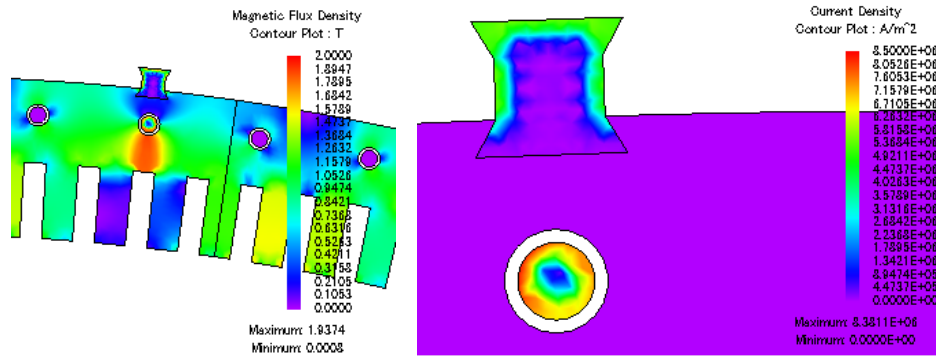
Fig 6. Magnetic flux density and eddy current distribution at no load condition with failure insulation

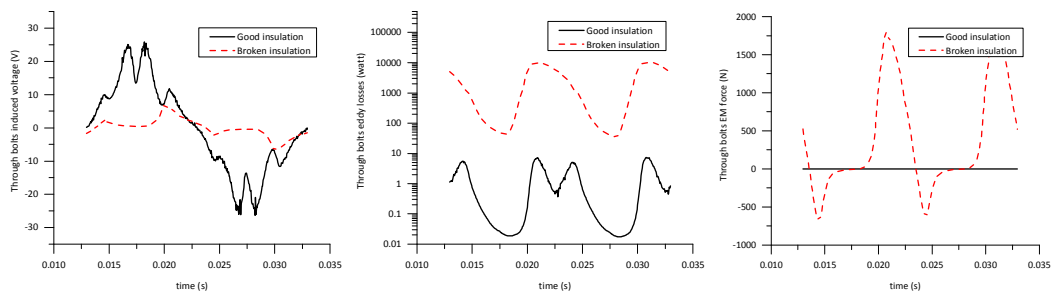
Fig 7. Induced voltage, eddy loss, electromagnetic force in through bolts

As the electromagnetic analysis, the EM force acted on the bolts is mainly 100Hz, which will result large vibration in the bolts.

- When the bolt insulation is good, the eddy current and the electromagnetic force is negligible;
- When the insulation fails, the eddy loss can be very high. At the most serious condition, the eddy loss is about 3kW per bolt, and the loss density is about 22 times the stator coil value. The loss would make the bolts melt;
- The electromagnetic force is mainly 100Hz, 2.5kN per bolt.

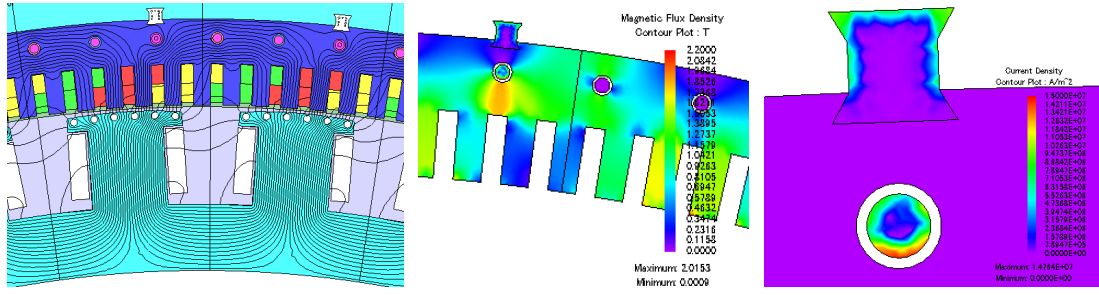
Fig 8. Magnetic flux line, density and eddy current distribution at no load condition with failure insulation

As the result of rated load showing in fig. 8, because of the armature reacting, the flux lines are twisted. And the flux linkage between the key bar and through bolt are also changed compared to no load condition, which also influenced the flux density and eddy current distribution.

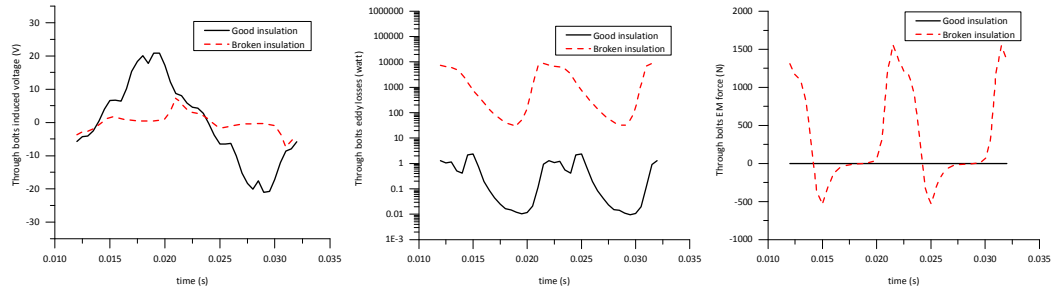
Fig 9. Induced voltage, eddy loss, electromagnetic force in through bolts at rated load

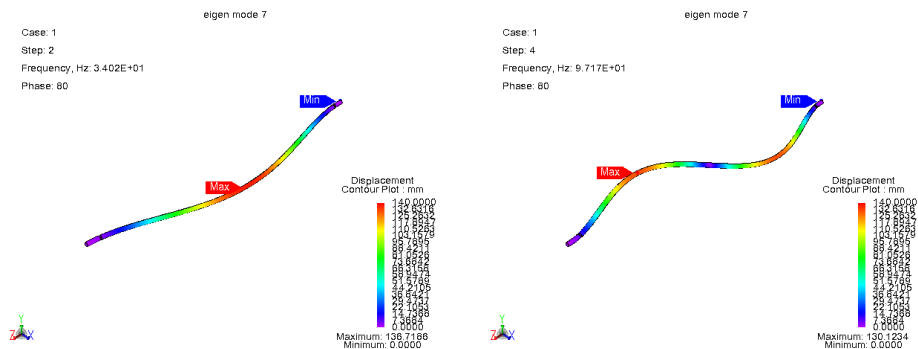
Firstly, a 2-support schemes is evaluated, which means the bolts are fixed only with the nuts at end part. Results show that the second order natural frequency is 97.2Hz, which is too close to 100Hz, the electromagnetic force frequency. According to the electromagnetic simulation, resonance will happen in the bolt.

Fig. 10 Modal analysis of 2 supports scheme

After long time of service, the tighten force gradually decreases, and the natural frequency is decreased to near 100Hz, stimulating the resonance and making the mechanical and insulation failure.

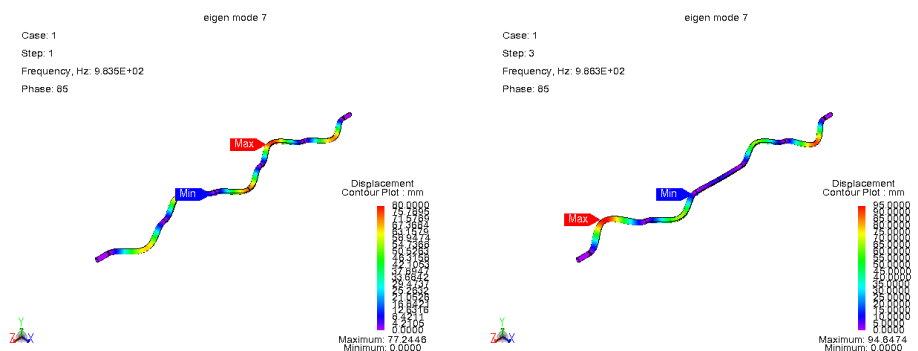
Secondly, a 7-support schemes is evaluated, which stands for the situation in which the bolts are also fixed well with the core in active part except the end part fixation. Results show that the natural frequency is higher than 983.5Hz, and it is far away from the 100Hz, the EM force frequency.

Fig. 11 Modal analysis of 7 supports scheme

By this means, we can take corresponding measures to increase the natural frequency to avoid resonance of the through bolts.
