CIGRE-US National Committee
2020 Next Generation Network Paper Competition

Monitor Data Management for Transformer Failure Prevention

A. ZAFRIS, R. CORNELL
AEP Collective Membership
Engineer
AEP Transmission
Professional with Less than Ten Years of Experience
ajsutliff@aep.com

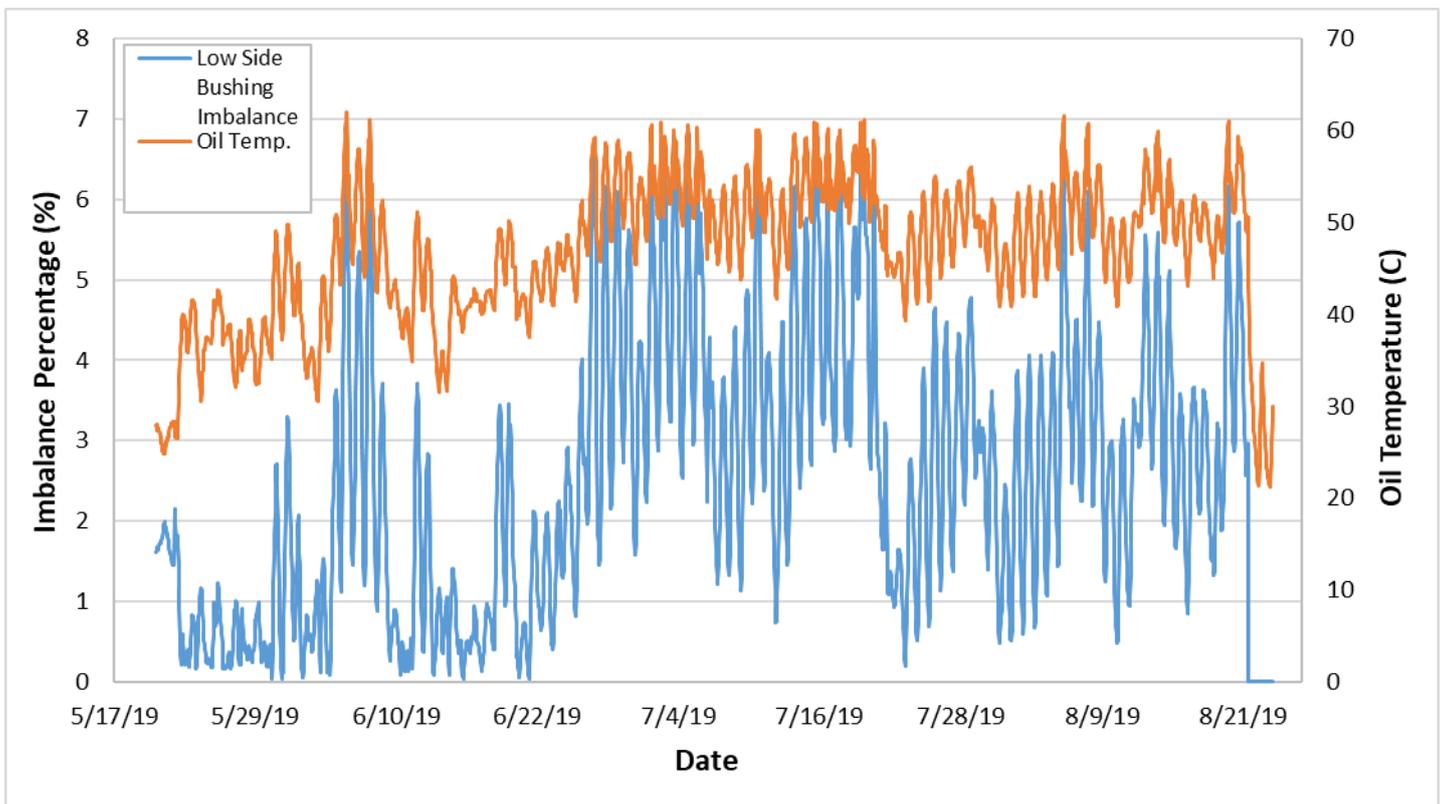
By sending bushing health alarms to asset monitoring personnel and involving AEP's Transmission Operations group at the appropriate time, two bushing failures have already been prevented. The first case involved a 345kV to 138kV autotransformer, which initially alarmed on bushing temperature dependency. As shown below in Figure 4, the low side bushing imbalance percentage correlated strongly with the transformer oil temperature. This correlation is a good indication of a real bushing issue. In addition to the temperature dependency alarm, the low side bushing imbalance percentage exceeded the warning and alert thresholds before the transformer was removed from service.

Figure 4: 345kV to 138kV Autotransformer Low Side Bushing Imbalance Percentage and Oil Temperature

This situation evolved over a series of months while asset monitoring personnel analyzed the data and collaborated with the monitor manufacturer. Ultimately, asset monitoring personnel worked with AEP's Transmission Operations group to remove the transformer from service. The X1 bushing was replaced, preventing a transformer failure. Moisture ingress is believed to be the root cause of this bushing issue.

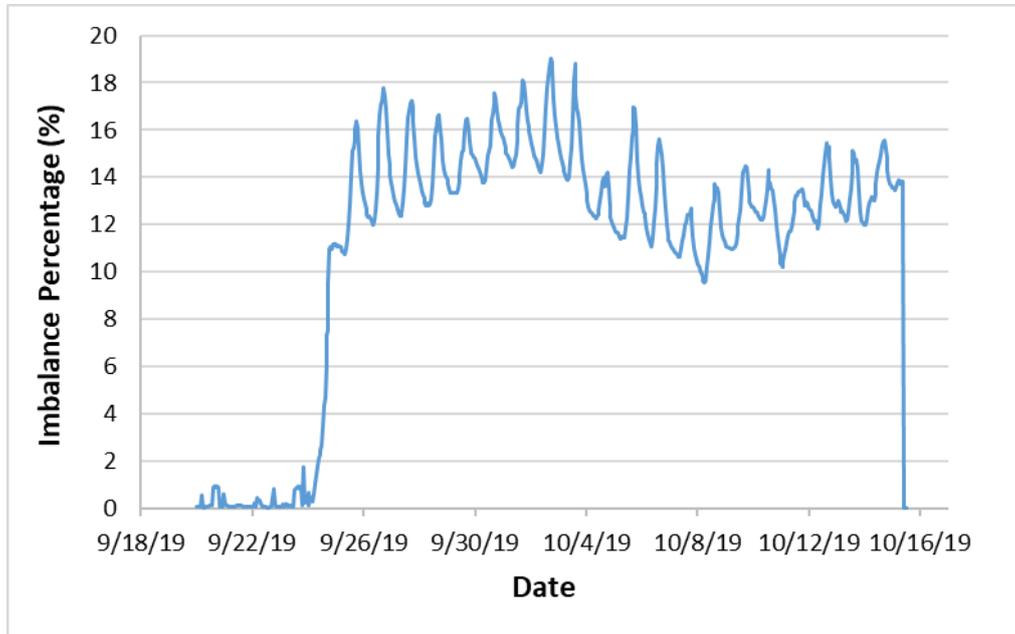
The second case involved a 138kV to 69kV autotransformer, which alarmed on bushing imbalance percentage for the low side bushings. The low side bushing imbalance percentage quickly rose to 11% and then fluctuated between 10% and 19% until the transformer was removed from service three weeks later. The low side bushing imbalance percentage during this timeframe is shown below in Figure 5.

Figure 5: 138kV to 69kV Autotransformer Low Side Bushing Imbalance Percentage

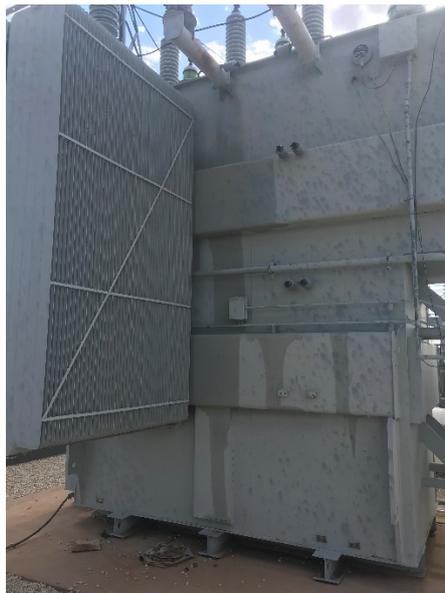
During this three-week timeframe, asset monitoring personnel analyzed the bushing data, collaborated with the monitor manufacturer, and requested an on-site inspection. The inspection revealed oil leaking from the X2 bushing and running down the side of the transformer, as shown below in Figure 6. An outage was taken to address the failing X2 bushing.

Figure 6: 138kV to 69kV Autotransformer Oil Leak [5]

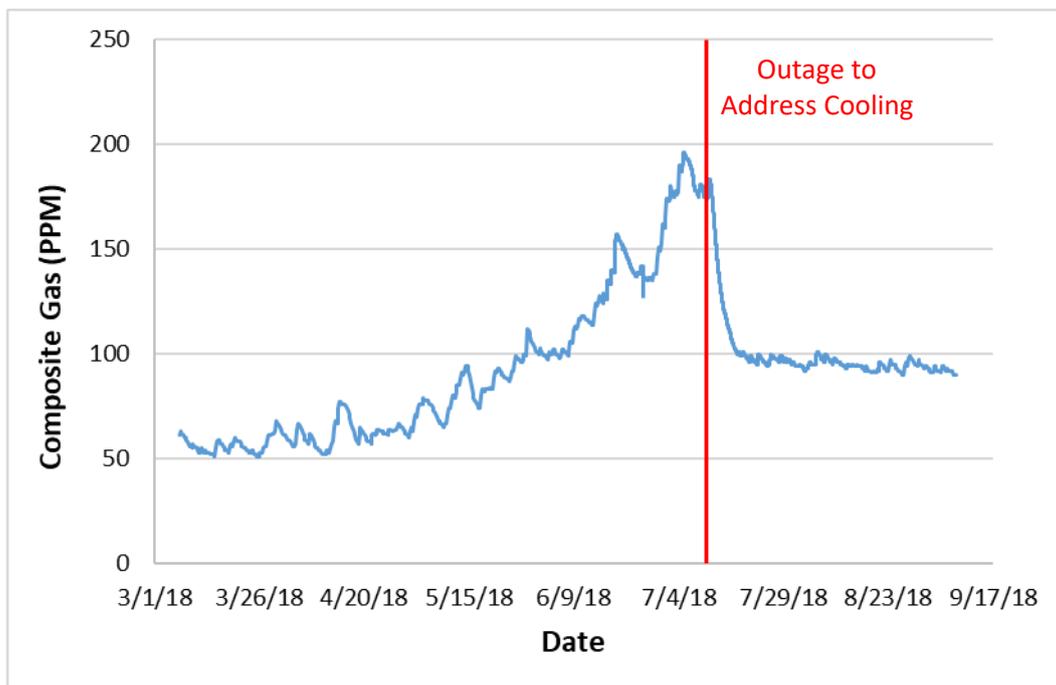
For example, the composite gas reading for a 345kV to 138kV autotransformer reached the lower level of criticality, causing AEP's Transmission Operations group to receive an alarm. The Transmission Operations group contacted the appropriate field personnel who performed further investigation on site during normal business hours. Their analysis found that the transformer's cooling system was ineffective due to residue on the radiators. An outage was scheduled to clean the radiators and ensure the functionality of the cooling system. Figure 7 shows that the composite gas reading dropped significantly after the scheduled outage.

Figure 7: 345kV to 138kV Autotransformer Composite Gas Reading

Addressing this situation over a number of days was effective. The inadequate cooling was addressed before it led to a catastrophic event. These cases, like so many others, highlight the importance of understanding data and assigning alarms appropriately.

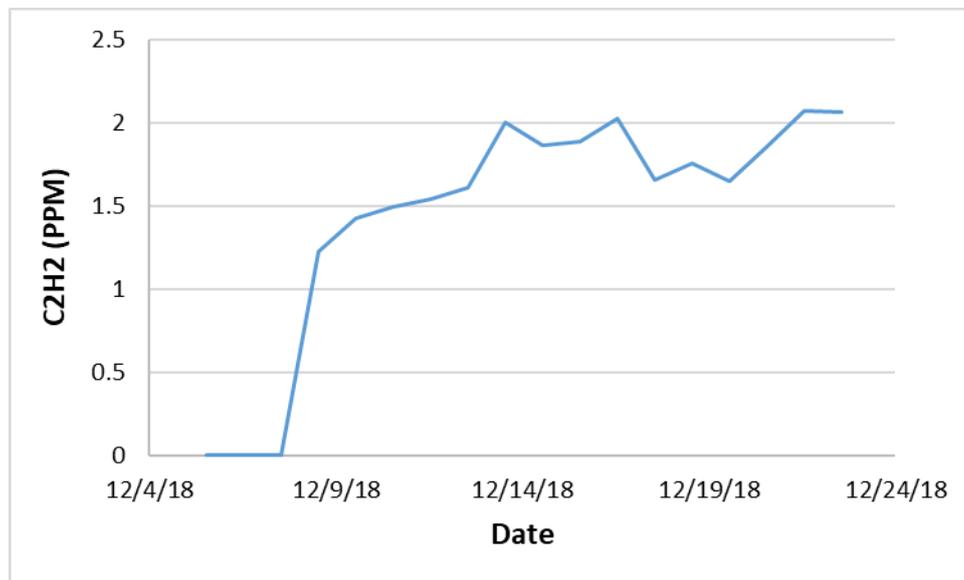
After the transformer was removed from service, further analysis was conducted. The online DGA monitor showed an upward trend in the concentrations of multiple gases, including acetylene. The acetylene concentration trend is shown below in Figure 8. The concentration was below the warning threshold for acetylene, but the increasing trend corroborated the abnormal pressure alarm.

Figure 8: 345kV to 138kV Autotransformer Acetylene Reading

Additionally, an onsite inspection revealed contamination on the top pressure ring, tertiary lead exit and shipping support beam. The contamination appeared to be caused by loose nuts and washers from the shipping support beam. The onsite findings further confirmed the issue identified by the abnormal pressure alarm and the acetylene trend. Quick action by field personnel, prompted by the alarm received by the Transmission Operations group, prevented a potentially catastrophic failure, which could have damaged other assets at the station. The transformer was sent to the factory for repair.
