CIGRE US National Committee 2016 Grid of the Future Symposium

Using Power Quality Data for Capacitor Bank Health Assessment and Failure Prevention

T. LAUGHNER, A. MURPHY Tennessee Valley Authority USA

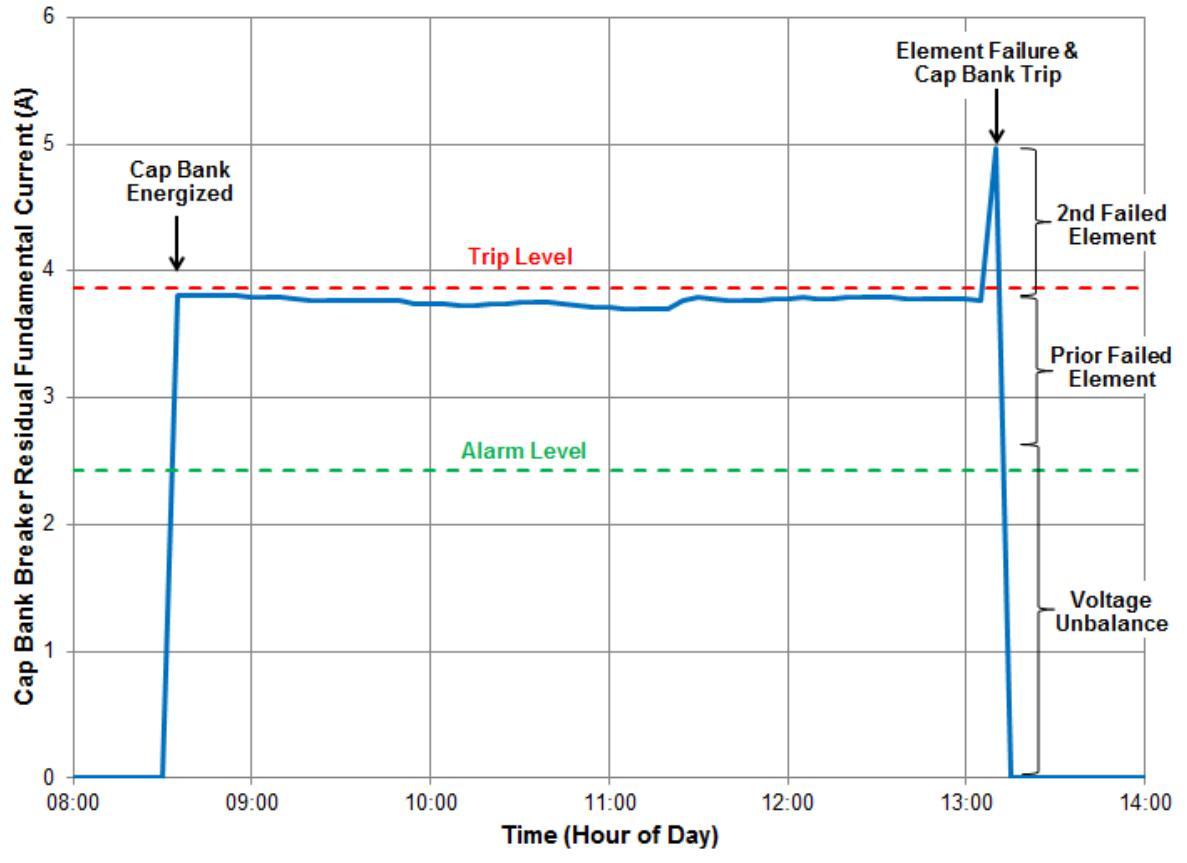
Figure 2 illustrates a case where a capacitor bank tripped offline a few hours after energization due to the unbalance protection. The unbalance protection was configured to trip upon the fourth shorted element. After reviewing the data from the PQM, it was determined that an element in B-phase had indeed shorted just prior to the capacitor bank trip; however, the data also indicated that this was only the second shorted element in B-phase and there were no shorted elements in the other two phases. The remainder of the unbalance was attributable to the system voltage unbalance for which the protection relay was not compensated. The system voltage unbalance was of sufficient level that it placed the unbalance protection above the alarm limit resulting in continuous alarming. This also only allowed enough margin for two element failures (instead of four) before the unbalance protection

would trip the capacitor bank. Waveform data recorded by the PQM proved very beneficial in making this detail of determination.

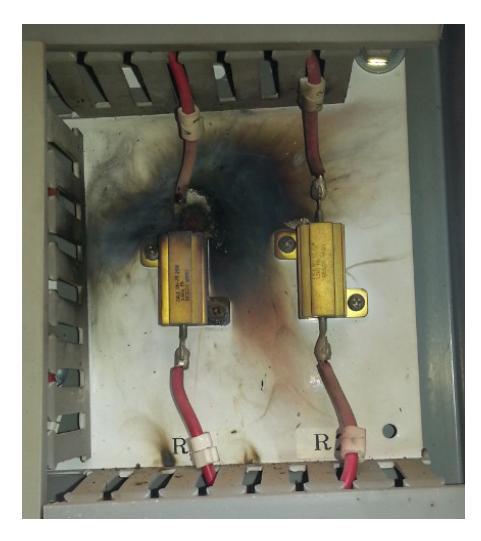
Figure 3

TVA has experienced cases of catastrophic failure of capacitor banks. The cost to replace such a failed capacitor bank has been over \$300,000. In such cases, the unbalance protection had effectively been disabled due to a failure of a capacitor or resistor (as shown in Figure 3) in the low voltage protection circuit. At some later time, the capacitor units would also fail. In the absence of effective unbalance protection, the remaining good capacitor units would be subjected to increasing levels of overvoltage leading to a cascading failure and eventual bus fault. The PQM can also monitor the control voltage at the back of the relay. Analysis of this data may be automated and notifications sent should the control voltage be lost before a catastrophic failure occurs.

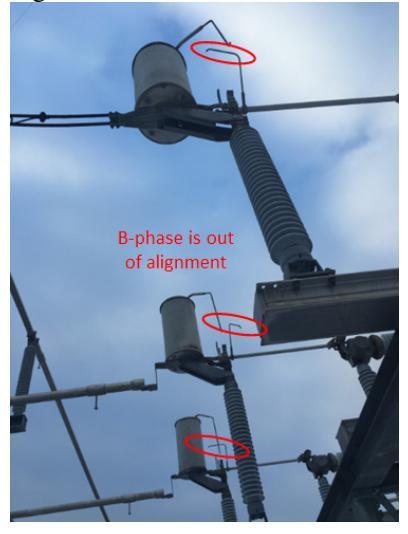
The same data recorded by the PQM can also be used to assess issues with the breaker and circuit switchers used to operate the capacitor banks. Each time a breaker or switcher is opened or closed the PQM will trigger a waveform event. From this waveform data, the timing of the device may be determined and compared against historical operations in order to alert any changes. Alignment issues with the switcher mechanism can also be determined. TVA has experienced instances where the pre-insertion inductors were never contacted during the closing sequence which led to higher than expected transient overvoltages during capacitor energization. The PQMs record these transient overvoltage waveforms from which automated analysis can be made and notifications sent. Figure 4 shows a switcher where the set bolt had come out allowing the B-phase arcing horn to rotate out of alignment. Multiple PQMs had recorded the excessive transient overvoltage on B-phase.

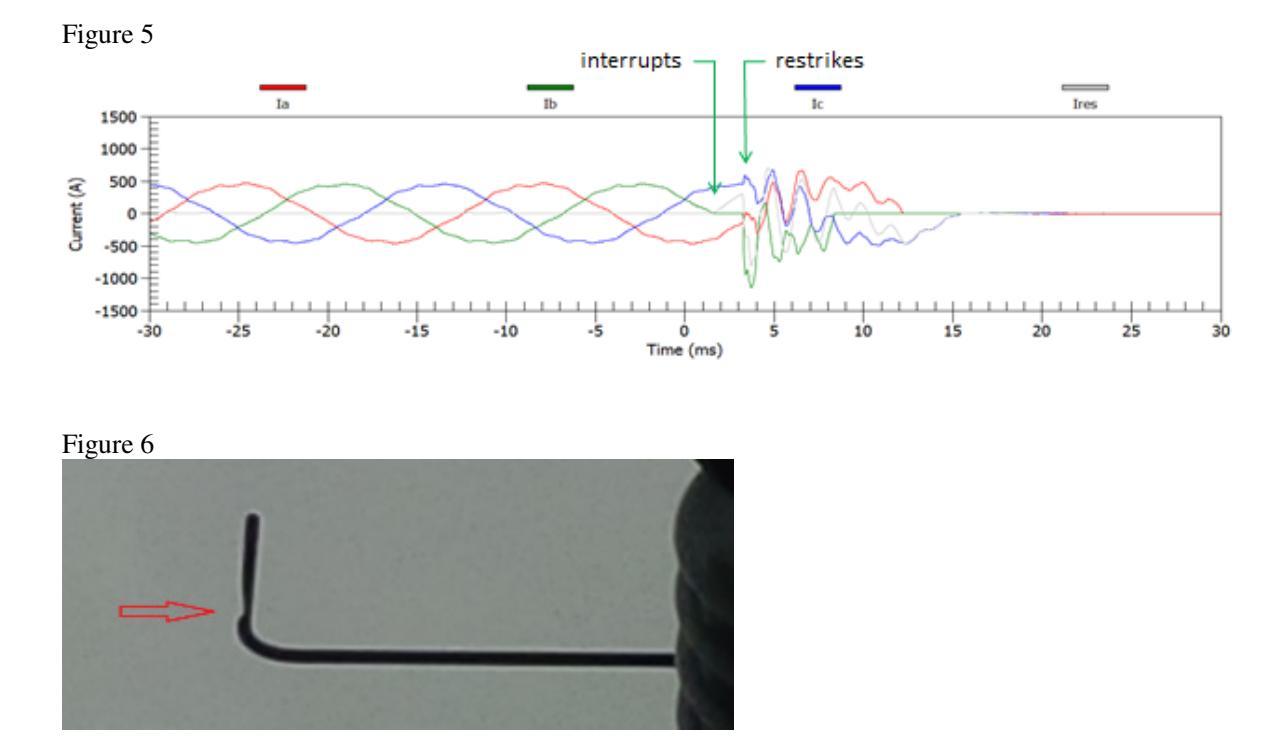
Since the PQMs record a waveform each time the switcher or breaker is opened, alerts for restrikes can also be made. Figure 5 shows an example restrike waveform recorded by a PQM. A subsequent investigation found an alignment issue with the capacitor switcher which had led to arcing and pitting along the arcing horn as shown in Figure 6.
