## **CIGRE US National Committee 2015 Grid of the Future Symposium**

### **Determining Crossing Conductor Clearance Using Line-Mounted LiDAR**

**J.C. MCCALL†, P. SPILLANE, K. LINDSEY**  
**Lindsey Manufacturing**  
**USA**

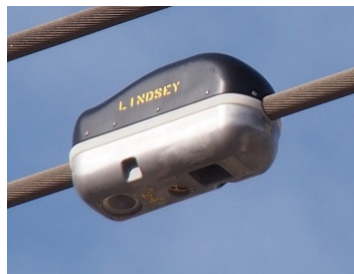
To accomplish the required real-time direct conductor clearance, ENMAX chose to use a novel conductor mounted monitor called the TLM® conductor monitor. This device provides a complete picture of conductor behavior including actual conductor clearance-to-ground, conductor temperature, line current, and vibration. The TLM monitor directly provides accurate, actionable, clearance-to-ground distance. See Figure 1.

Figure 1: TLM Conductor Monitor

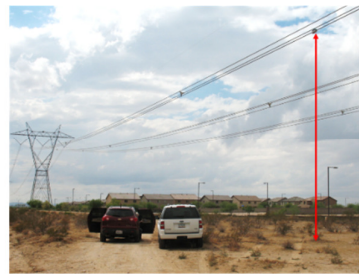
Figure 2: Location of LiDAR measurement taken from installed conductor monitor

The distance of the nearest object to the conductor is measured using an on-board LiDAR (i.e., Light Detection And Ranging) sensor providing a highly accurate ( $\pm 0.3\%$  at 40m) line clearance measurement regardless of tower or insulator motion, varying span lengths, or other line conditions [6]. See Figure 2.

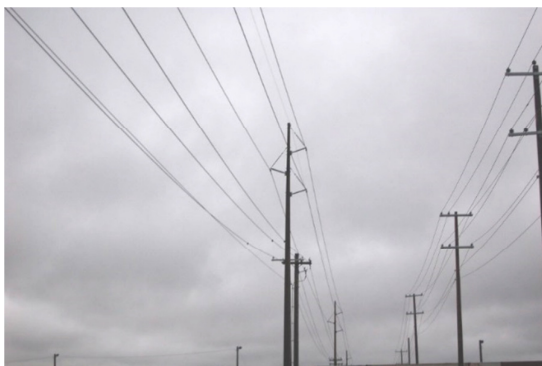
The particular application need facing ENMAX required knowledge of the clearance between the co-located 138kV and 25kV lines along line for a length of 9.3km. The sensor's LiDAR unit performs a measurement sweep perpendicular to the conductor as part of its method to correct for conductor rotation due to heating, conductor swing, and to adapt to under build and undergrowth. However, this sweep does not allow for the accurate measurement from the 138kV line directly to the 25kV line below; the 25kV conductor presents too small of a target. To address this situation, it was decided to mount a sensor in the lowest phase of the 138kV line and the nearest phase of the 25kV circuit. See Figures 3 and 4. Measurements would then be taken from each conductor to ground, with the difference between the two measurements being the clearance between the conductors.

Figure3 (left): Photo of parallel 138kV and 25kV lines

Figure 4 (right): End view perspective

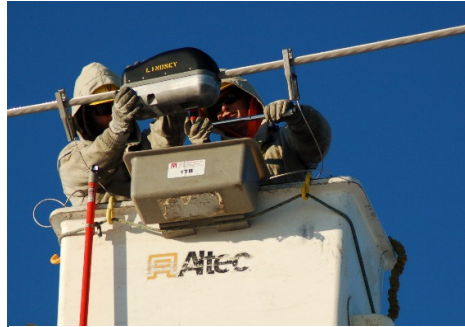
Figure 5: Live line installation of sensor

The initial project involved the installation of two TLM monitors each in two locations, for a total of four TLM monitors. Being pilot installations, the locations were chosen by ENMAX based on ease of access and proximity to the substation in which the communication gateway was installed, eliminating the need for any repeaters. Both spans were along the same straight right-of-way, so both spans were exposed to similar conditions. The spans were 115m and 107m in length. Even though the two sites were physically close, the presence of a small body of water resulted in a 5km drive between the installation sites. The monitors were installed using bare hand, live line installation methods. See Figure 5. The total elapsed time from arrival on site of the contractor crew to their departure was four hours. Figure 6 shows one set of the TLM conductor monitors immediately after installation.

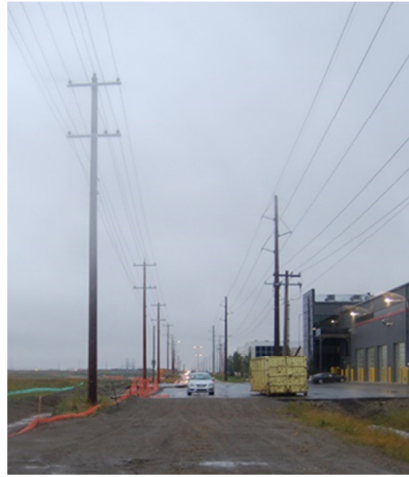
A site survey was completed before the installation. Figure 7 shows the environment around the line and where the conductor monitors would be installed. The lines are adjacent to a fairly busy light industrial commercial area with a fair amount of vehicle traffic. Although the sensors at each site are located roughly vertical from each other, it was identified that passing vehicular traffic may result in a sudden change in the reported distance to ground of the conductors, and during the vehicle's transit, possibly even a step change in the reported conductor-to-conductor clearance. See Figure 8.

Figure 7: Commercial / Industrial environment conductor clearance monitor installation

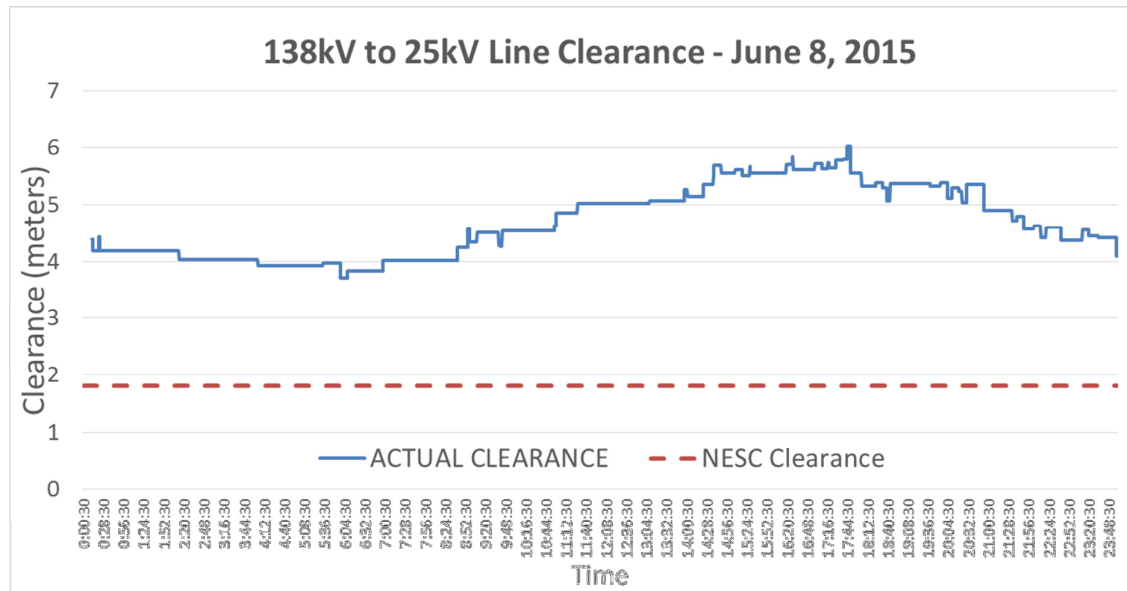
Figure 9 shows the measured clearance between the two lines at one of the TLM monitor locations for a one day period, June 8, 2015. The dashed line is the nominal NESC required clearance per Table 233-1. The actual clearance ranges from 3.7m to 6.0m during the course of the day, or a 2.3m change between the two lines. As would be expected, examination of the

underlying data shows most of the change is due to the 138kV line; only 0.3m of clearance difference was due to the 25kV distribution line. While there were moderate winds present in the afternoon that could result in some blowout, for the conductor used, this would account for approximately 0.5m of this difference. The current on the 138kV line ranged from 111A to 319A over the day. This change would not result in appreciable sag for the size of the conductor used. Therefore this change in clearance over the course of the day seemed much greater than expected.

Figure 9: Measured clearance on June 8, 2015 between the 138kV and 25kV lines at Span A based on one conductor mounted LiDAR-based monitor pair

As mentioned previously, two sets of spans were monitored. As the 25kV line clearance to ground varied little, the focus was brought to the 138kV spans. Figure 10 shows the clearance to ground over the course of the day of each of these two spans, marked Span A and Span B. Recall that both spans are roughly equal length at 115m and 107m (Span A and B respectively). Note that Span A is the span for which the conductor-to-conductor clearance is shown in Figure 9.

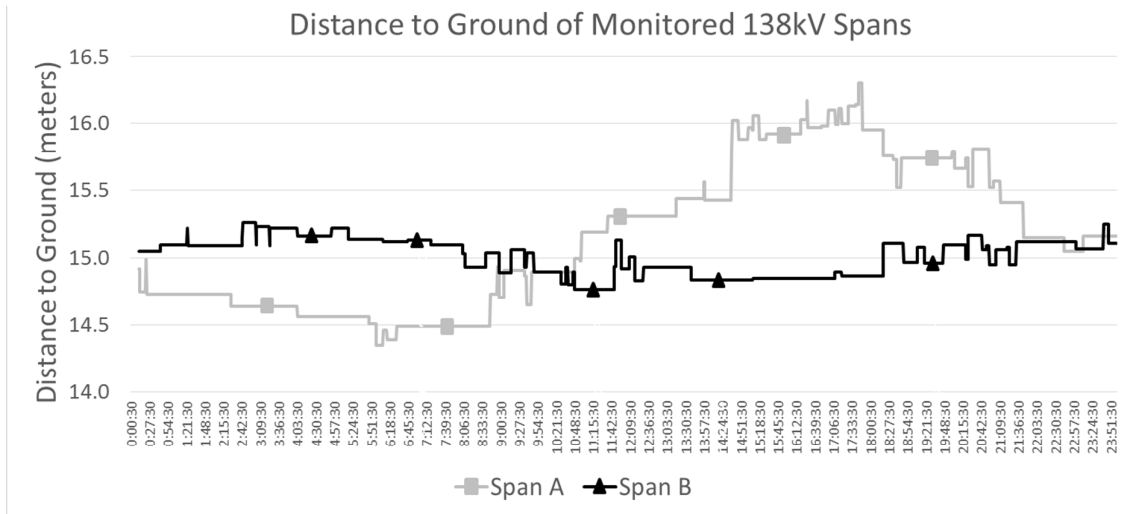
Figure 10: Distance to ground of 138kV lines for monitored Spans A and B

- Figure 10 shows the clearance to ground of Span B varies little over the course of the day (0.5m). However, as expected, in the afternoon as the conductor heats due to ambient temperature (approaching 32C from 3-5pm) and the modest current increase, the sag is greatest (lowest clearance). Note that the spans adjacent to Span B are at essentially the same elevation; all the spans will behave similarly.

- The clearance to ground of Span A has much more variation (1.8m). In addition, the variation is opposite that of Span B; that is, in the warm afternoon, the clearance to ground increases, meaning sag is decreasing.

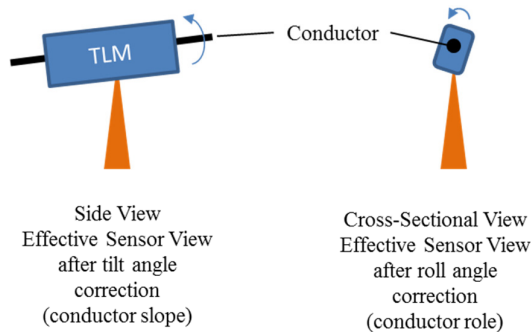
The LiDAR units in the conductor monitors are fixed. Therefore the LiDAR measurement is initially based on the direction the monitor is facing. To ensure the measurements are always made in reference to the downward facing direction the monitors contain tilt and roll sensors. The reported distance to ground is corrected for these measured angles. See Figure 12.

Figure 12: Tilt and Roll Correction
