CIGRE US National Committee 2017 Grid of the Future Symposium

Distributed Temperature Sensing in Secondary Networks

K. JENKINS, R. CONWELL
Indianapolis Power & Light Company
USA

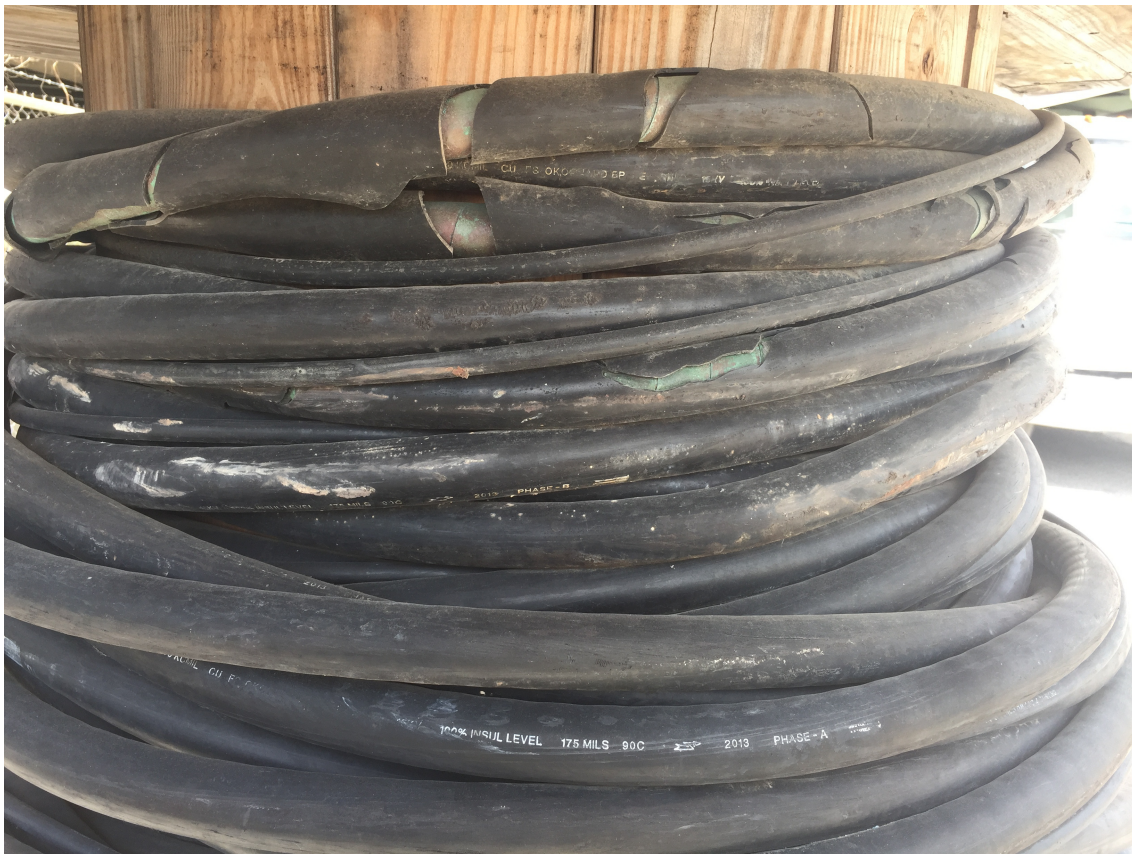
Figure 1: Cable Damaged by Elevated Temperatures Caused by Steam. Cable had been in Service for Only 2 Years.

Most manhole events can be attributed to low voltage cable faults due to damage to the cable's outer jacket and insulation. The damage, along with contributing factors such as; salt water, excessive loading, and external thermal sources, accelerates the thermal aging of the cable's outer jacket and insulation. The thermal aging causes the cable's insulation to become brittle and crack as shown in Figure 1 below. Once this has occurred, salt water from de-icing roads for instance, will aid in a cable fault, resulting in the thermal decomposition of the outer jacket and insulation. Combustible gasses created during the thermal decomposition of the cable start to build up in the duct line and manhole system, creating the perfect storm for an over-pressurization event. With this in mind, it is imperative for electrical utilities to minimize and mitigate the potential of such events from occurring.

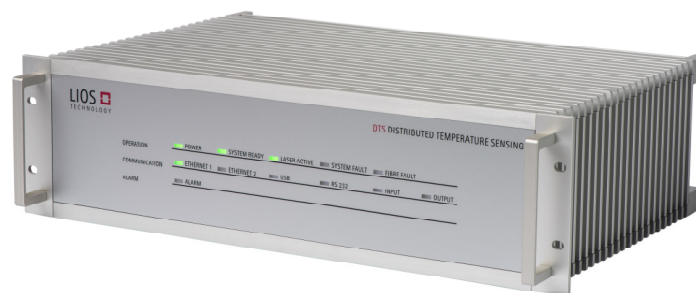
Figure 2: LIOS Distributed Temperature Sensing Controller

A DTS system is comprised of two components, a DTS controller like the one shown below in Figure 2 and standard fiber optic cables with lengths up to 30km+ each. The fiber optic cables can either be installed radially or looped to add robustness to the system.

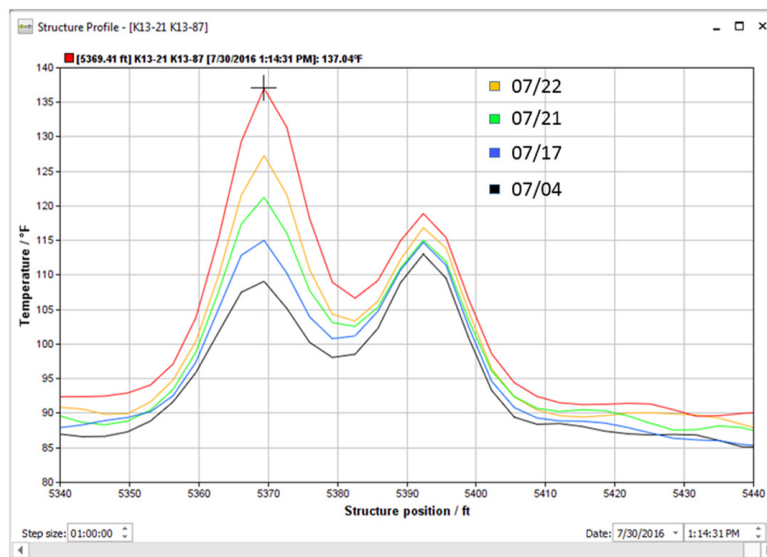
Figure 4: Steam Anomaly that Occurred in July 2016 Shortly after the IPL DTS System was installed.

One example shown below in Figures 4 and 5 illustrates the temperature trace of a steam anomaly that started at the beginning of July 2016. The temperature increase was gradual over a period of 30 days indicating it was a steam issue. The steam leak was 9 meters (30ft) from manhole K13-21. After further investigation with the steam company it was determined that an abandoned steam line running perpendicular to the IPL duct bank had not been properly capped off and was allowing a steam leak from the steam line on the opposite side of the street to travel towards the IPL duct bank. Due to the promising results from the pilot DTS installation, IPL management approved installing three additional routes and an additional DTS controller.

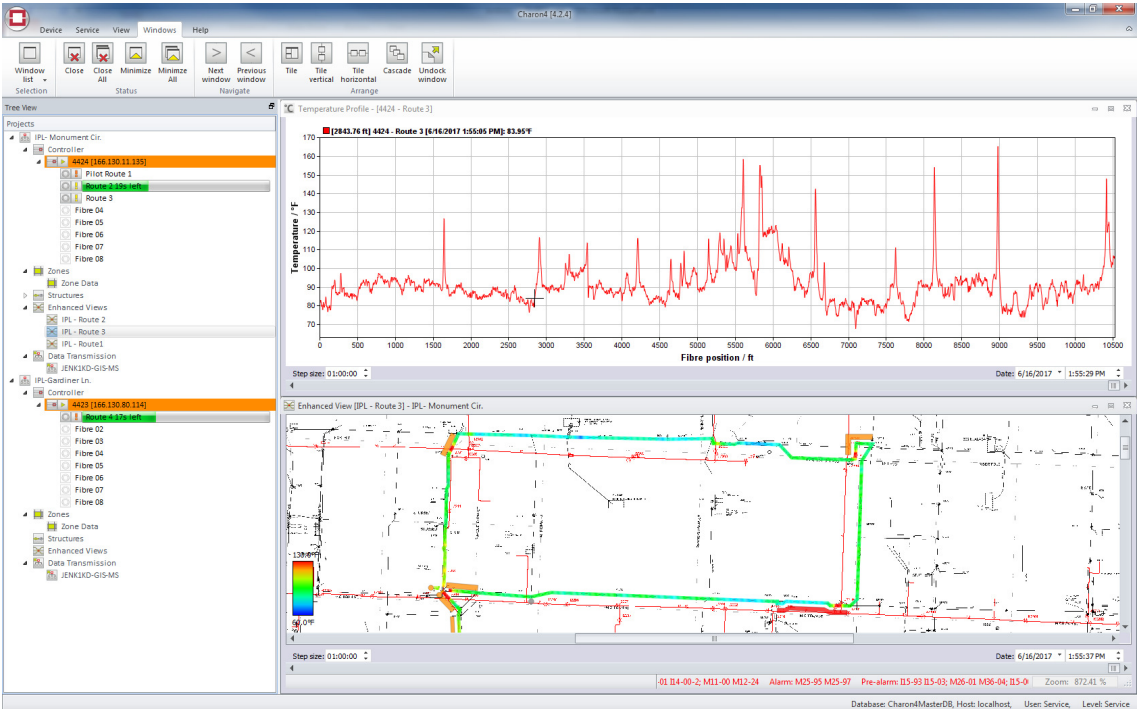
Figure 6: Charon 4 Software, Temperature Trace and “Enhanced View” of Route 3

Currently IPL has installed two DTS controllers at separate locations with four routes of fiber optic cable covering approximately 11.3km (37,000ft). To achieve the same amount of coverage of the DTS system, we would have needed to install and maintain approximately 11,300 sensors. The temperature traces of all four routes are updated every 90 seconds. The DTS system has detected several steam anomalies as well as cable fires in two manholes. Below in Figure 6 is a screenshot of the Charon 4 software with the temperature trace, the “Enhanced View”, and Figure 7 showing zone data of Route 3.
