CIGRE US National Committee
2019 Grid of the Future Symposium

Transmission Line Conductor Asset Health Assessment with Non- Contact Monitoring Technology

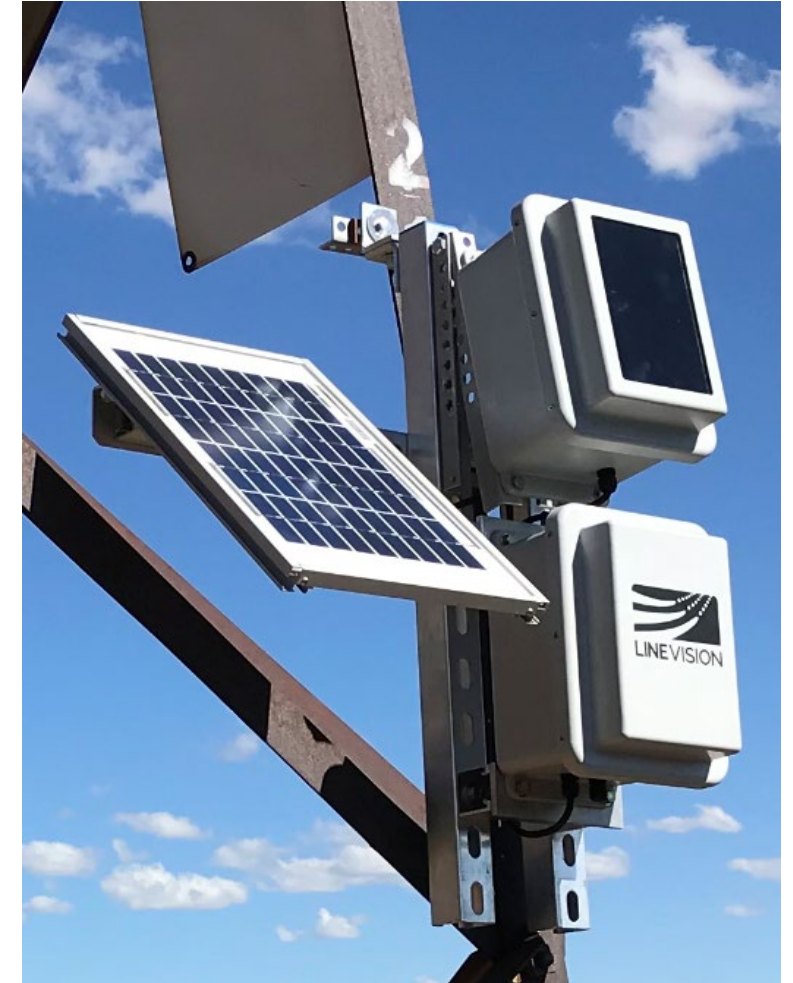
Unleashing the full potential of the grid with advanced sensors and analytics

- Patented and proven non-contact sensor technology with systems deployed worldwide
- No outages or specialized equipment required
- Turnkey system for ease of integration

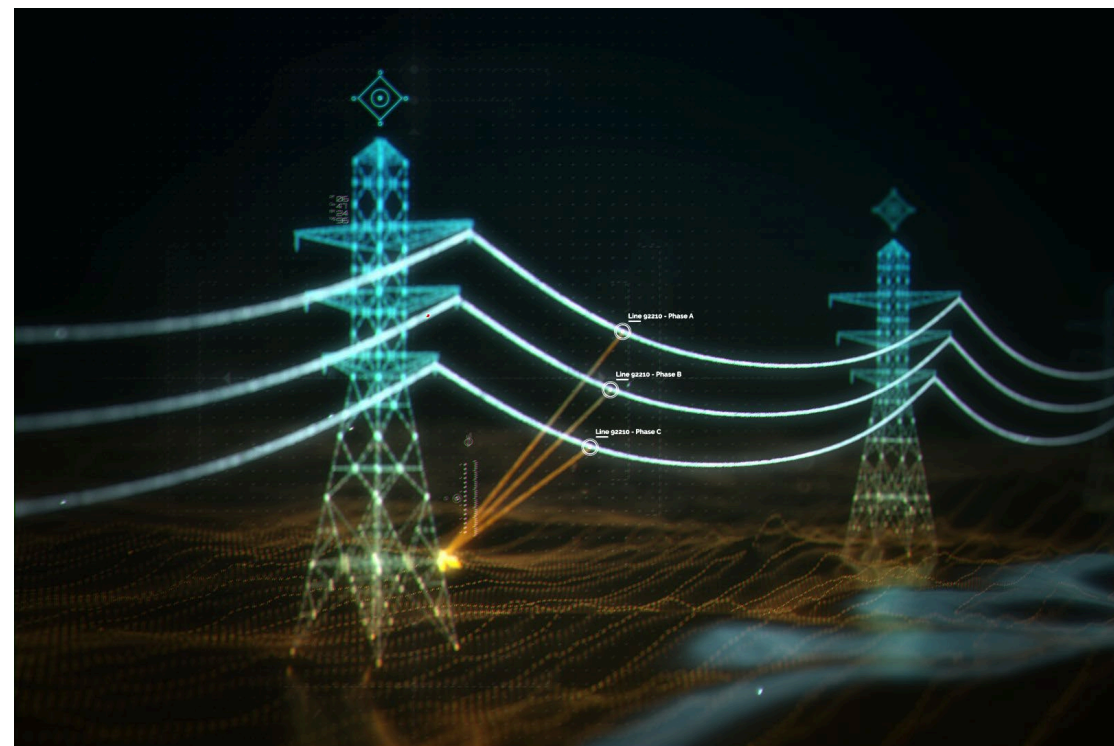
Methodology :

1. Measure fixed conductor heights at the insulators
2. Continuously scan in-span position of conductors
3. Reconstruct catenary shape / calculate sag

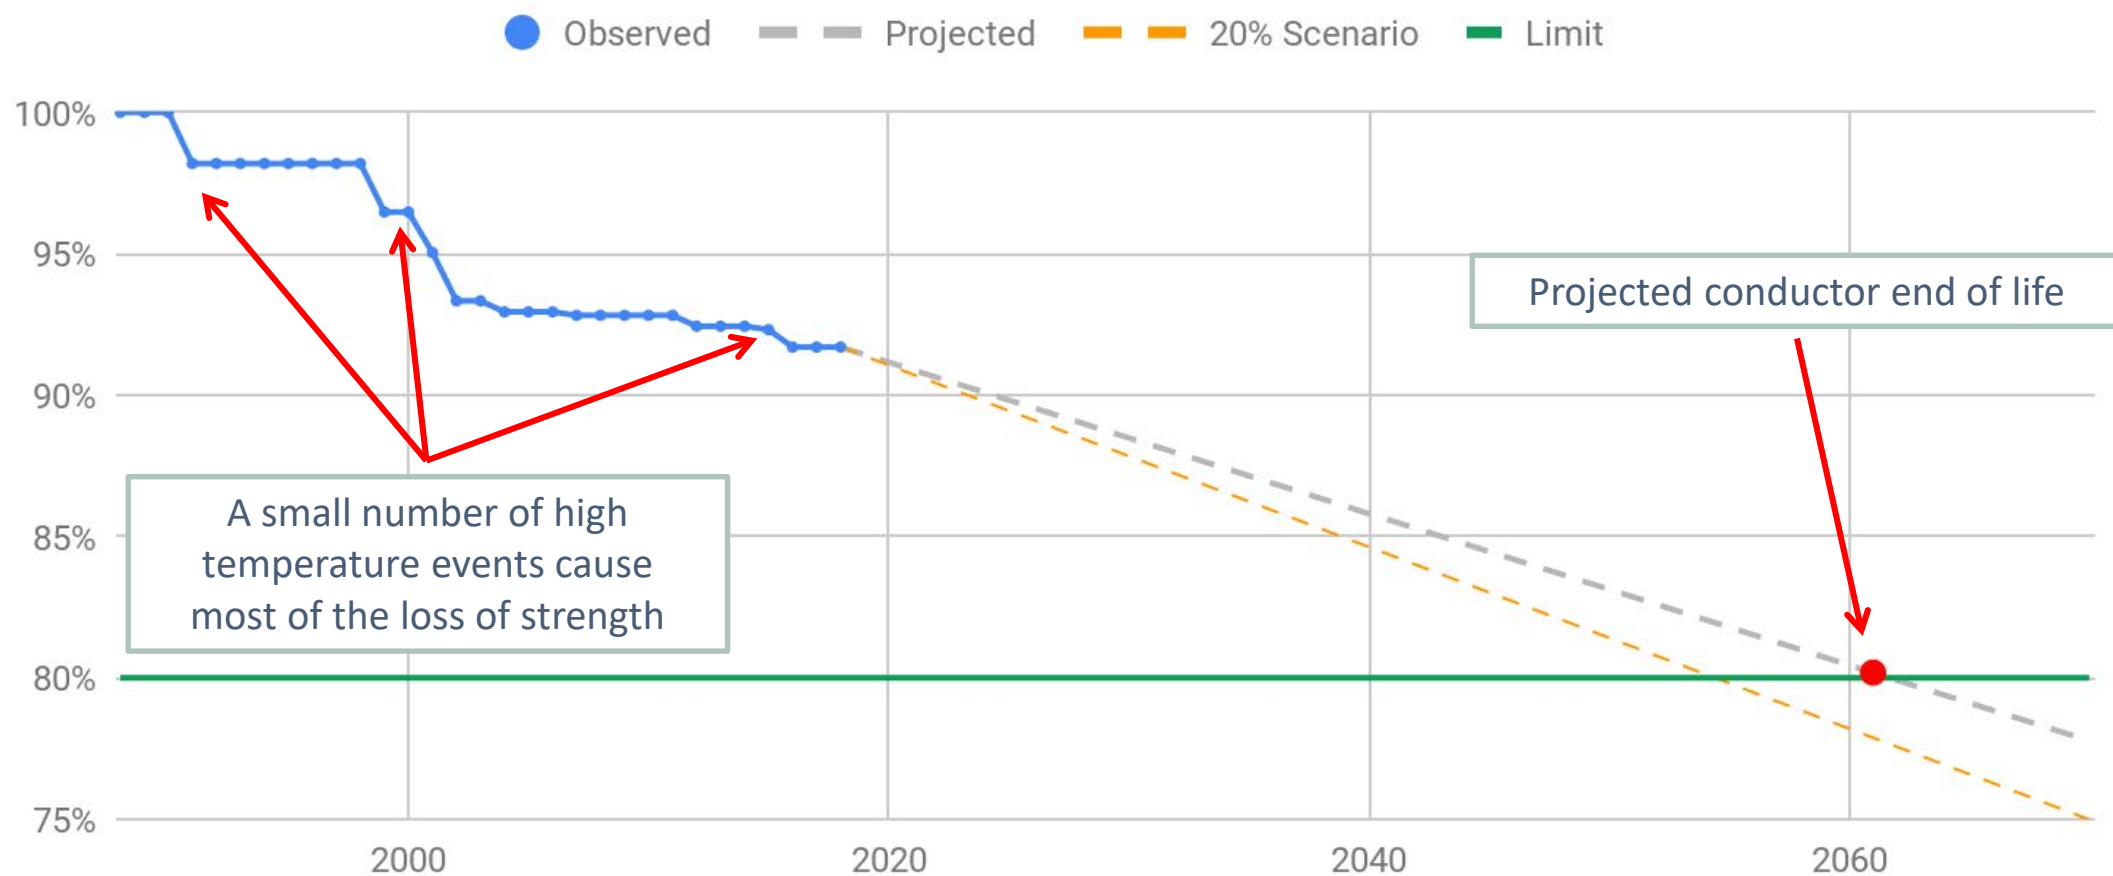
Thermal Aging Analysis

Elevated conductor temperatures cause annealing, resulting in loss of conductor strength.

Using industry standards, LineHealth computes the conductor strength loss over its lifetime and the end of life can be projected based on thermal aging history.

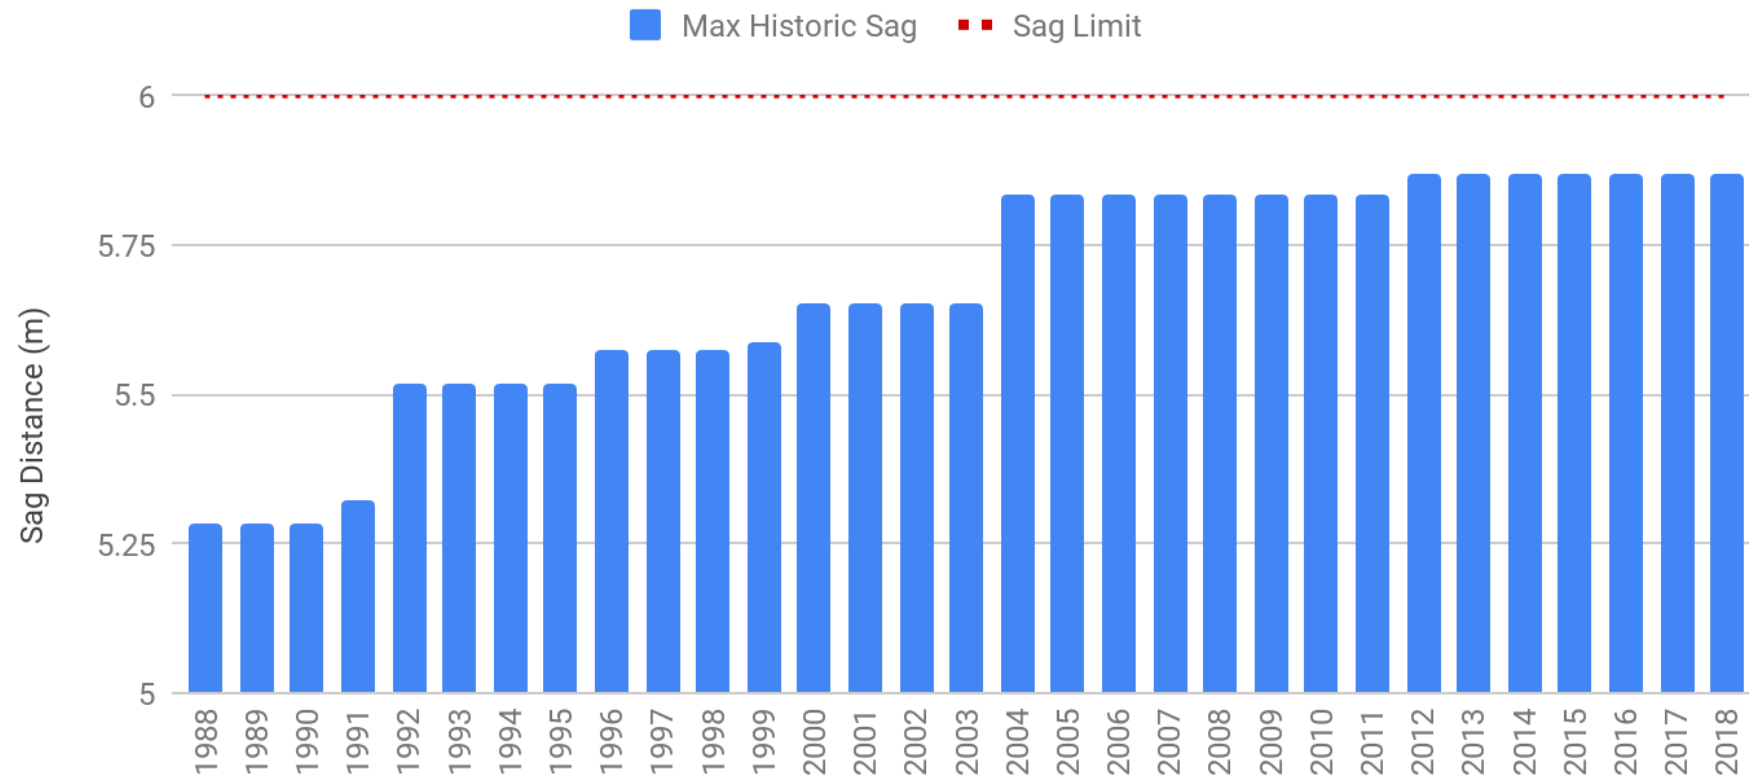
Max Historical Sag

Estimate the historical maximum sags from high temperature events.

- Excessive sag could indicate plastic deformation
- Data driven corrective actions *i.e.* re-tension
- Continuously monitor for new changes

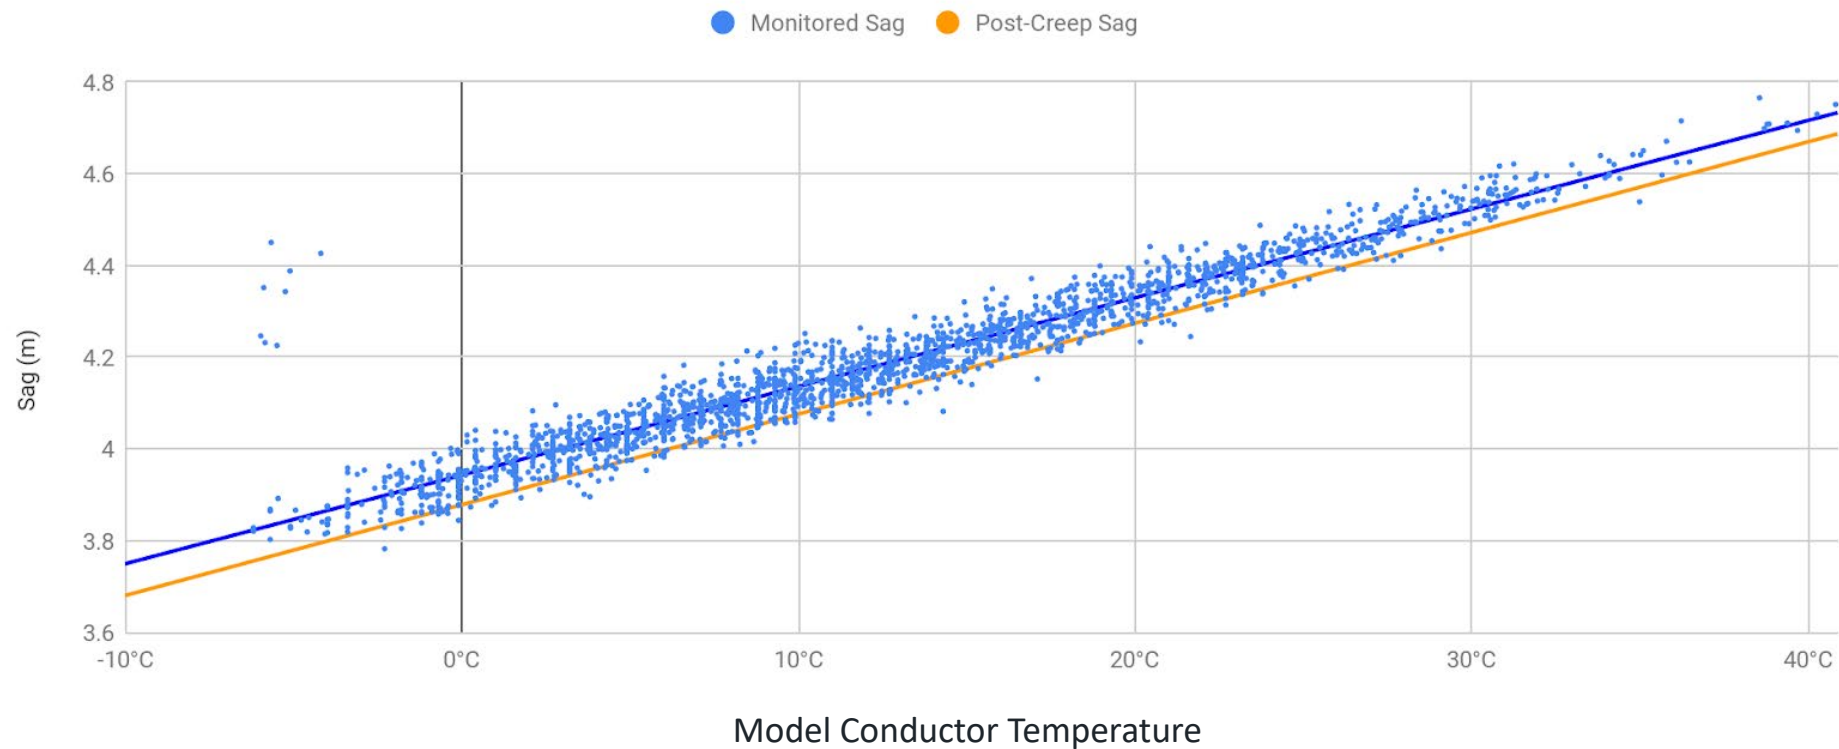
Monitored Sag vs Design Sag

Monitoring reveals deviation from design sag-temperature, suggesting elongation.

Sag has increased 17cm @ 15°C, compared to post-creep sag

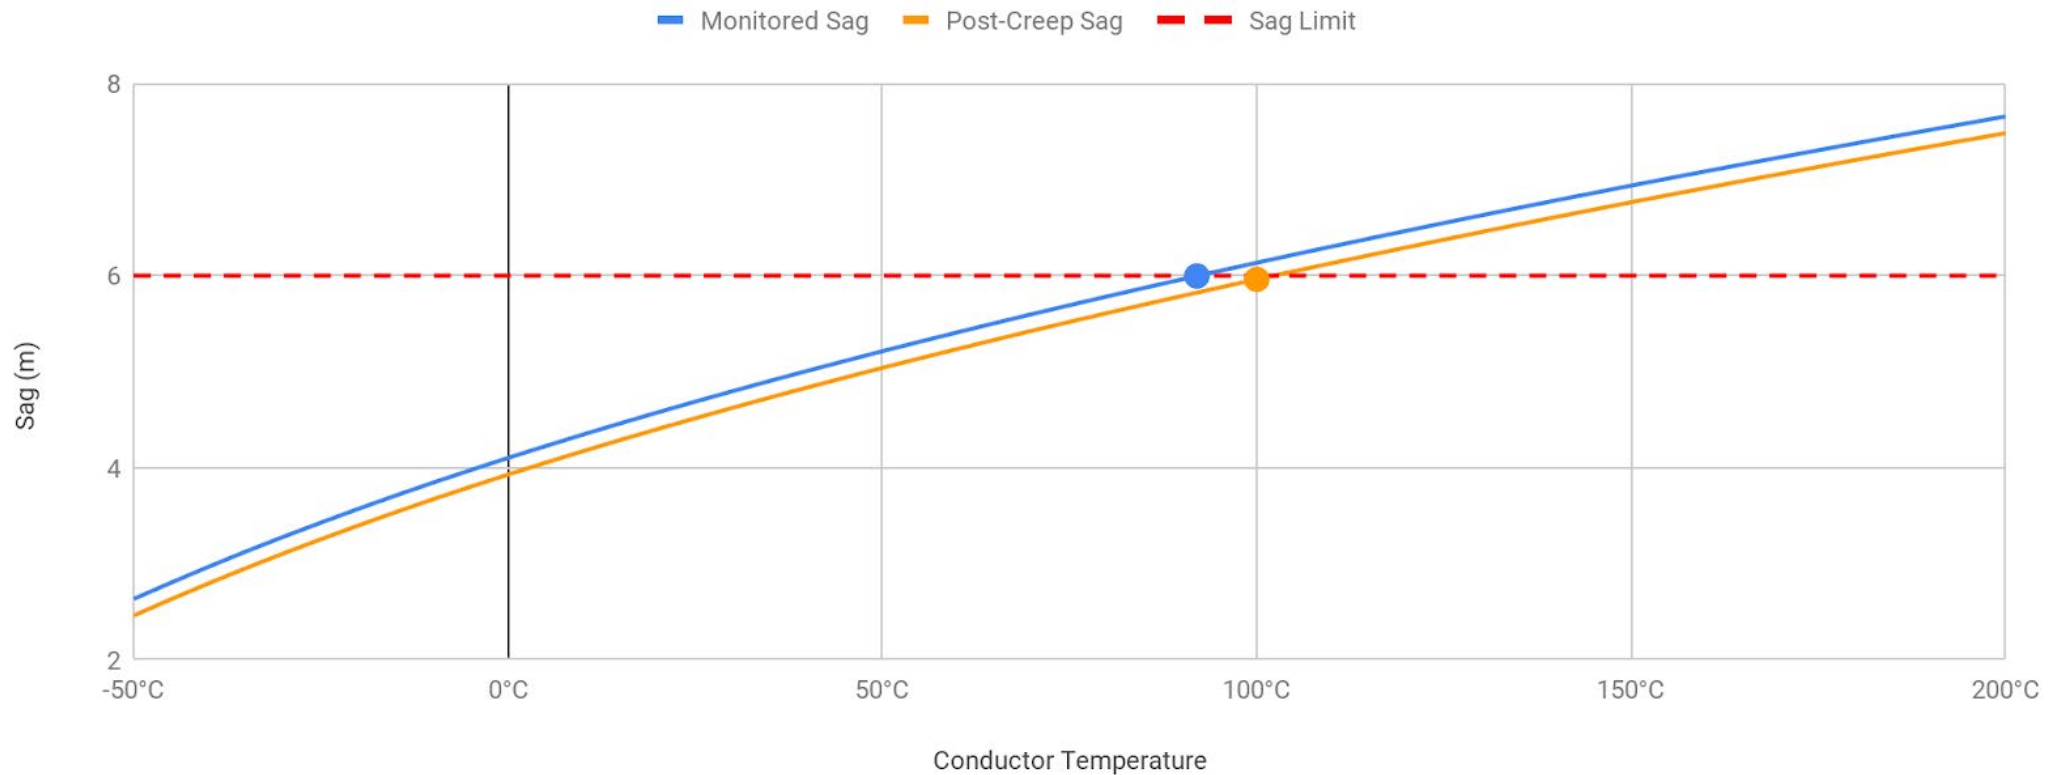
Monitored Sag Extrapolated vs Design

Operating Limit Recharacterization

If the line is limited by clearance, we can calculate the *new* limiting conductor temperature. Sag Limit of 6m will be reached at 92 degrees vs the design of 100 degrees.

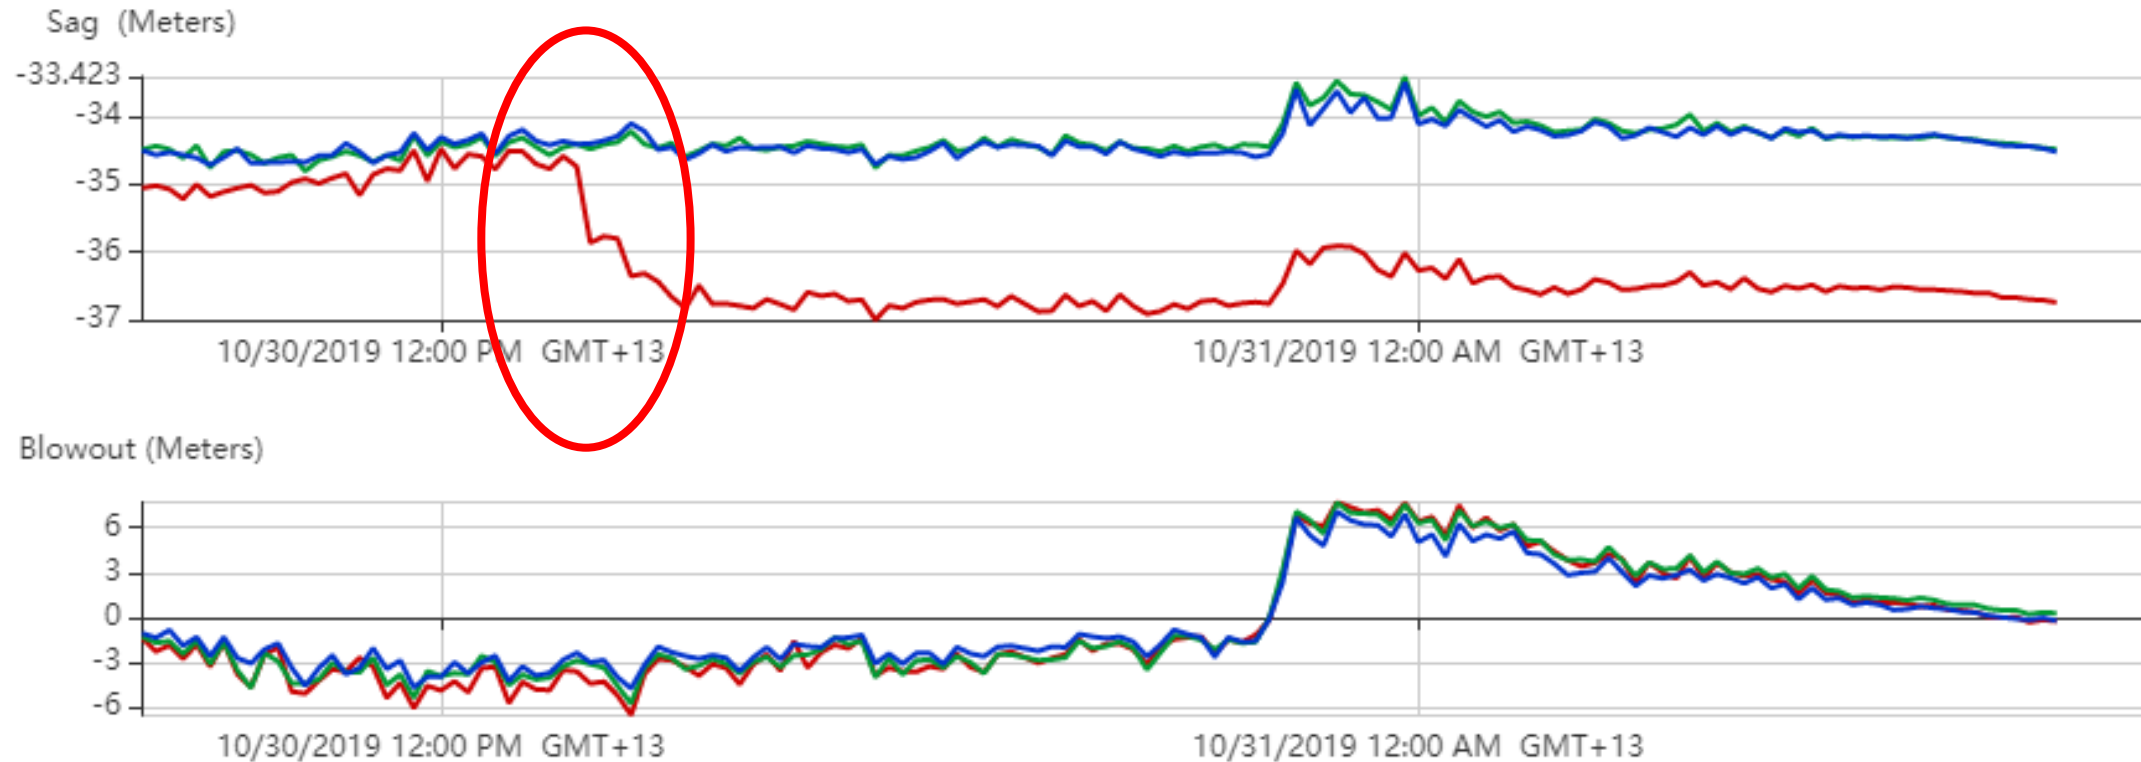
Anomalous Motion Detection

Digital twin model computes the expected conductor position and alerts upon discrepancies.

Anomalous motion of a single phase detected.

Alerts sent to operators.

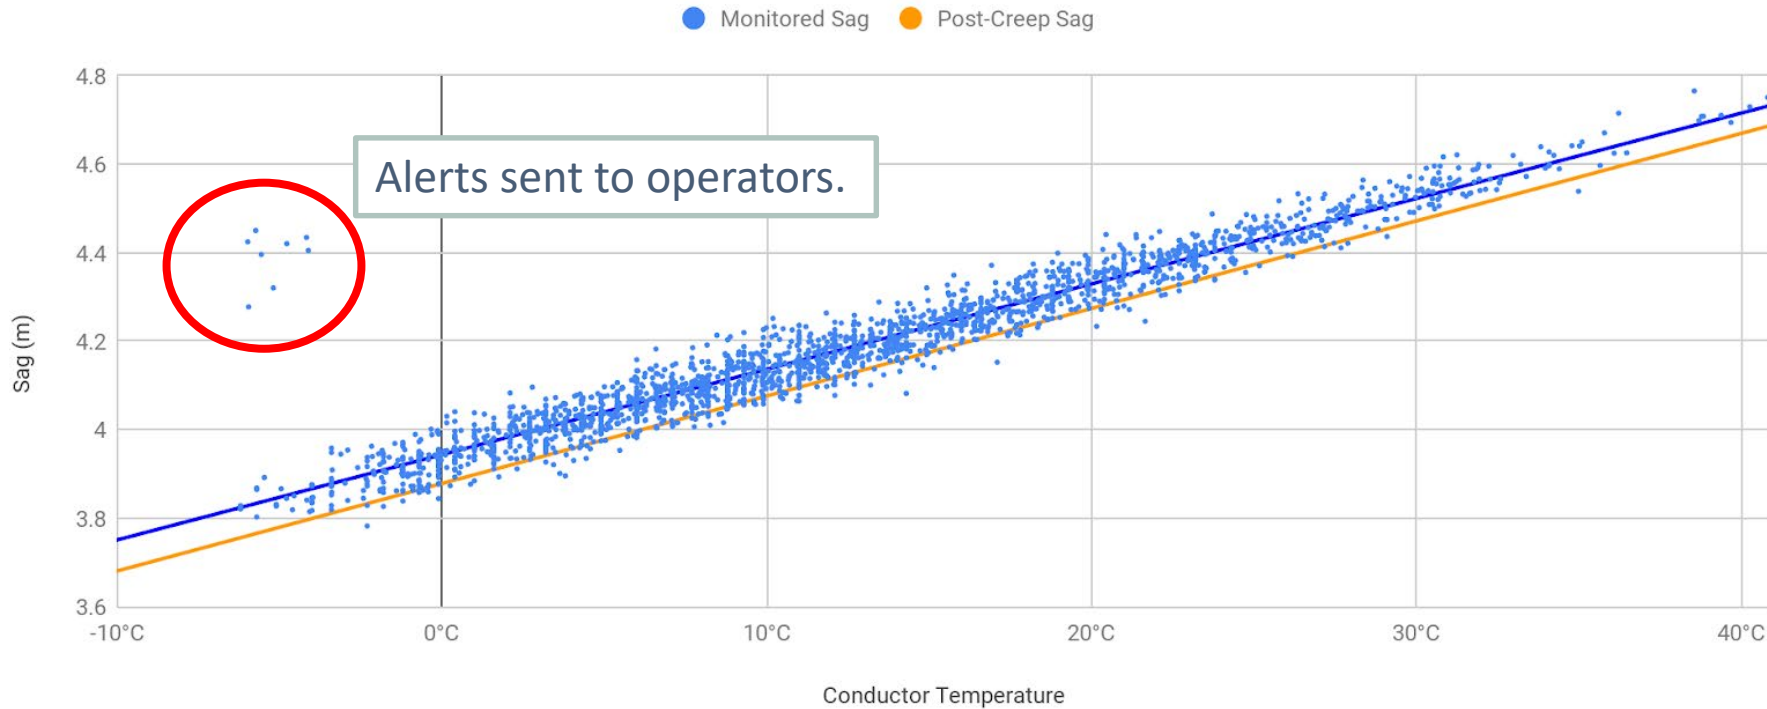
Monitored Sag vs Design Sag

V3 Monitoring has identified the following precipitation overload events in the last 6 months:

Date/time	Duration	Max Observed Sag	Expected Sag	Sag Deviation	Ice Weight / meter	Event Tension (N)	Conductor Temperature
1/20/2019	2hrs	4.45 m	3.97 m	0.48 m	14.58 N/m	26,514.40 N	-5 Degree C

Icing weight per meter & maximum tension calculated.

Shield / ground wire icing is also detected.

Re-check if plastic deformation occurred.

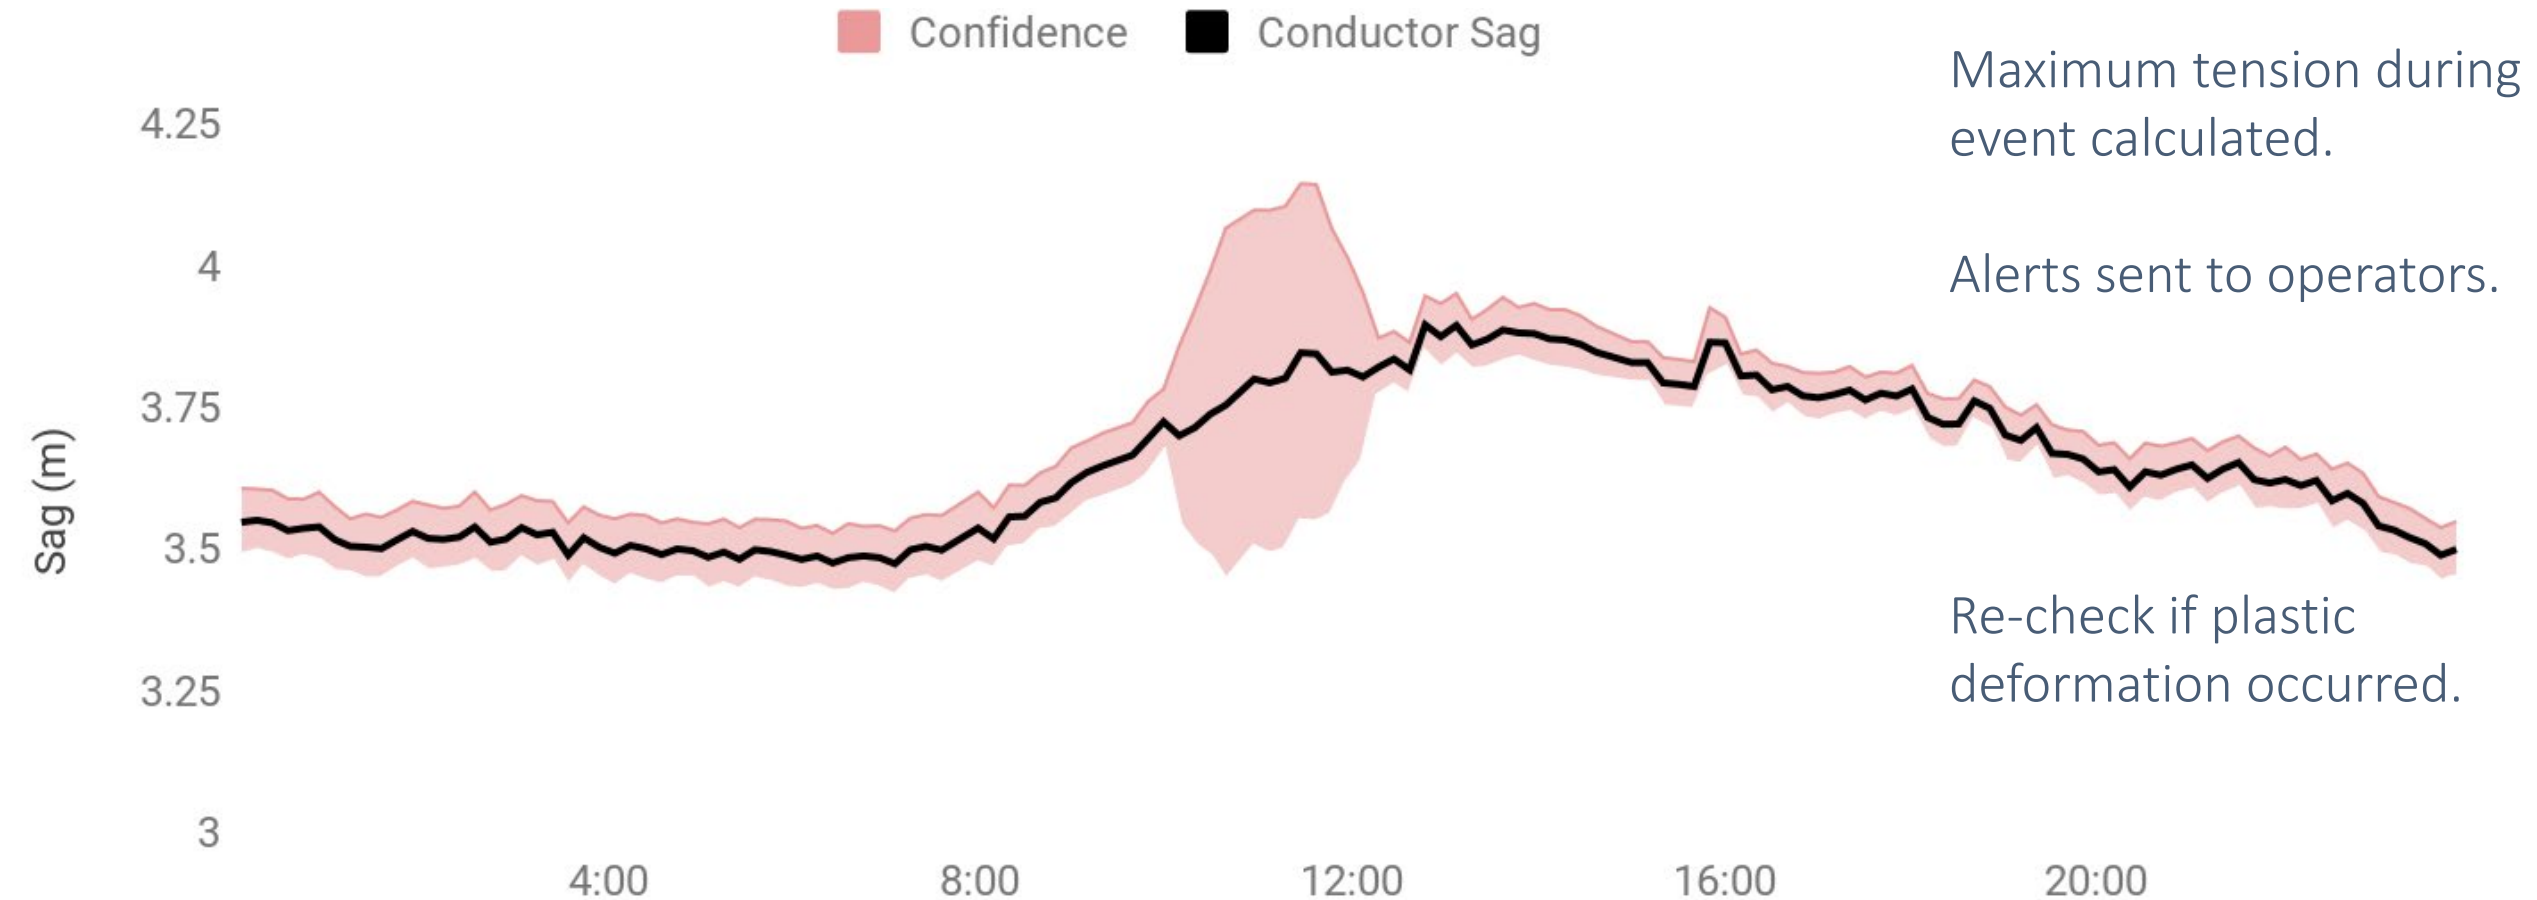
Galloping Detection

Variation in max and min observed sag in short periods of time that coincide with periods of elevated wind speeds indicates galloping could be occurring.
