**CIGRE US National Committee  
2022 Grid of the Future Symposium**

**Extending the Life of Overhead Aging Assets  
with a  
Focus on the Energized Portion of Transmission  
and Distribution Lines**

**CARL R. TAMM  
Classic Connectors, Inc  
U.S.A.**

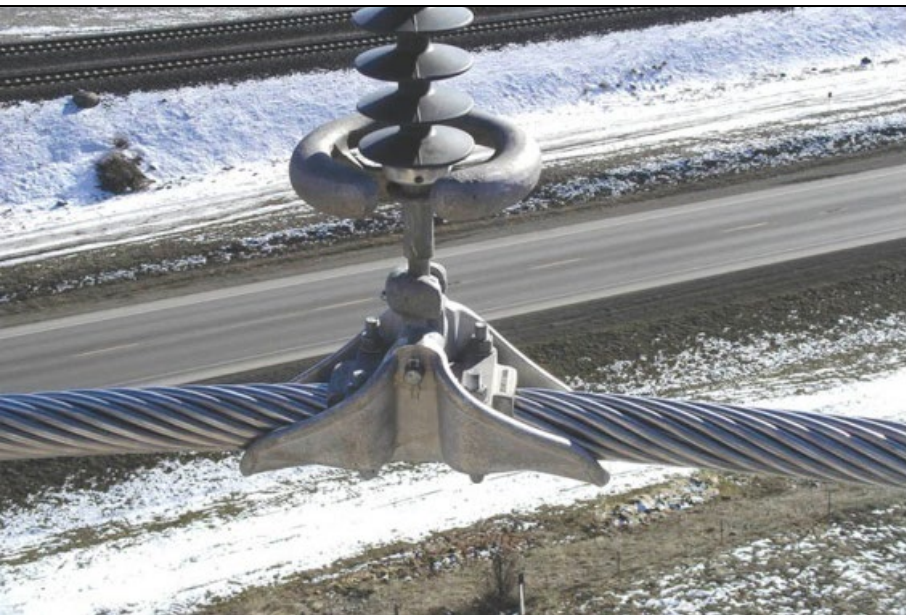
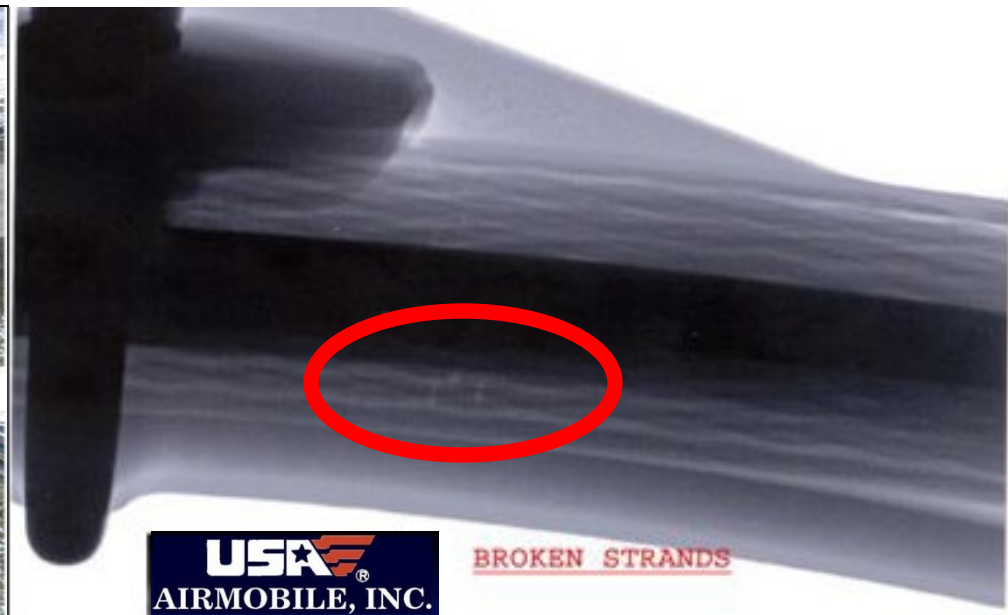
X-Ray Commonly Reveals Broken Strands in Suspension Clamps

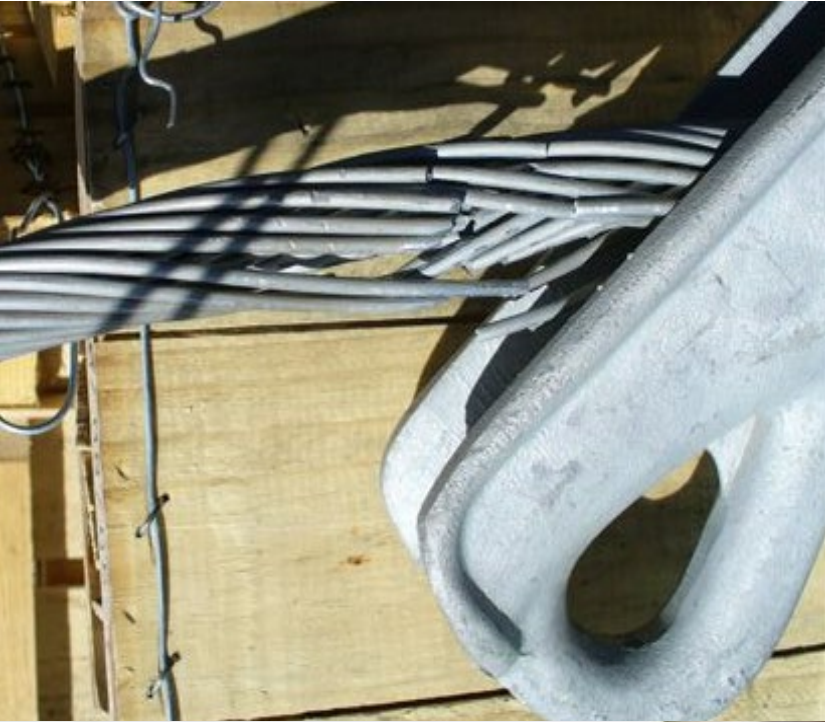
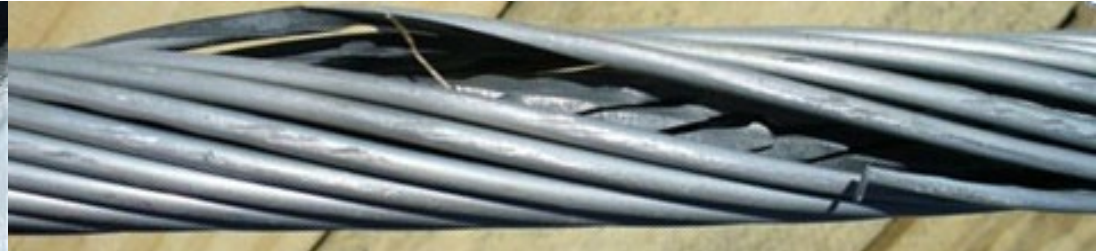
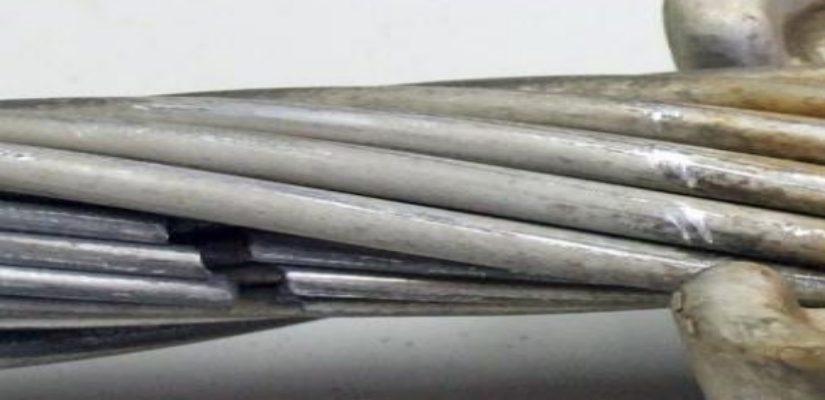
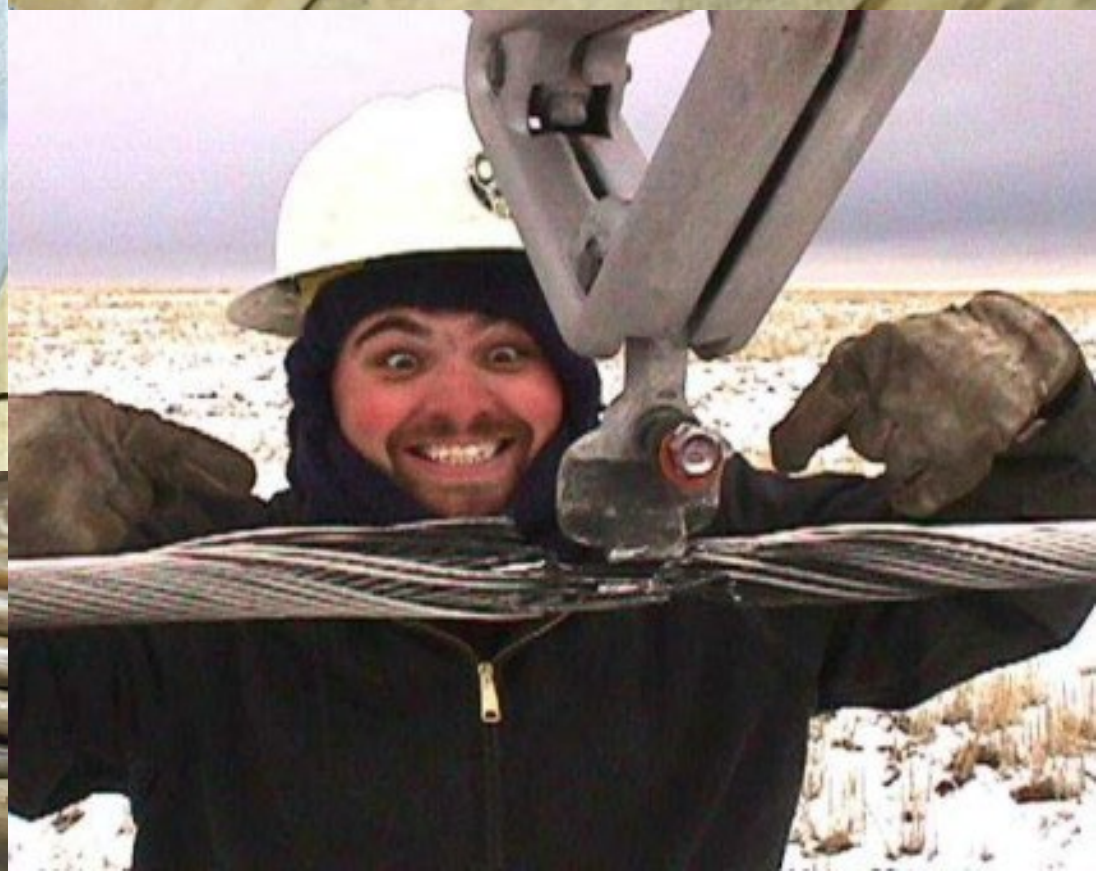
Broken Strands in Strain Clamps, Spacers, Under Helical Rods

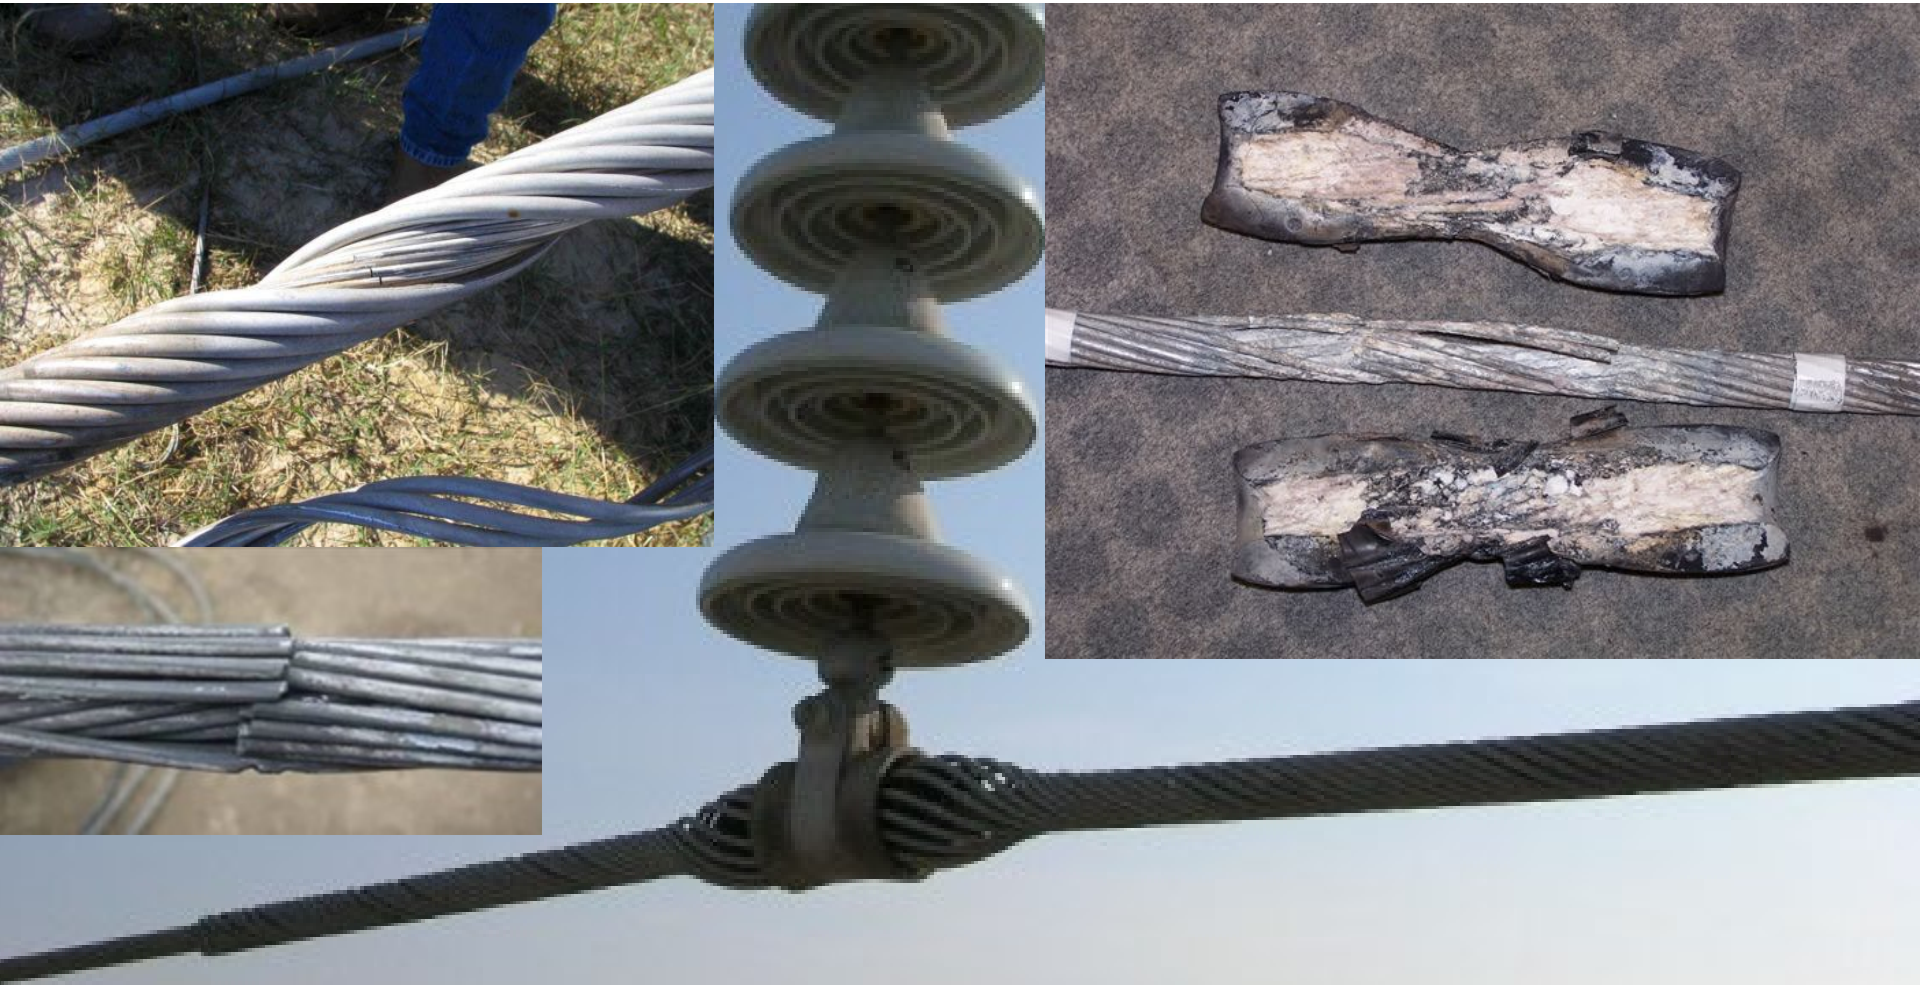
# Conductor Fatigue and Corrosion under Rods and helical type Suspension

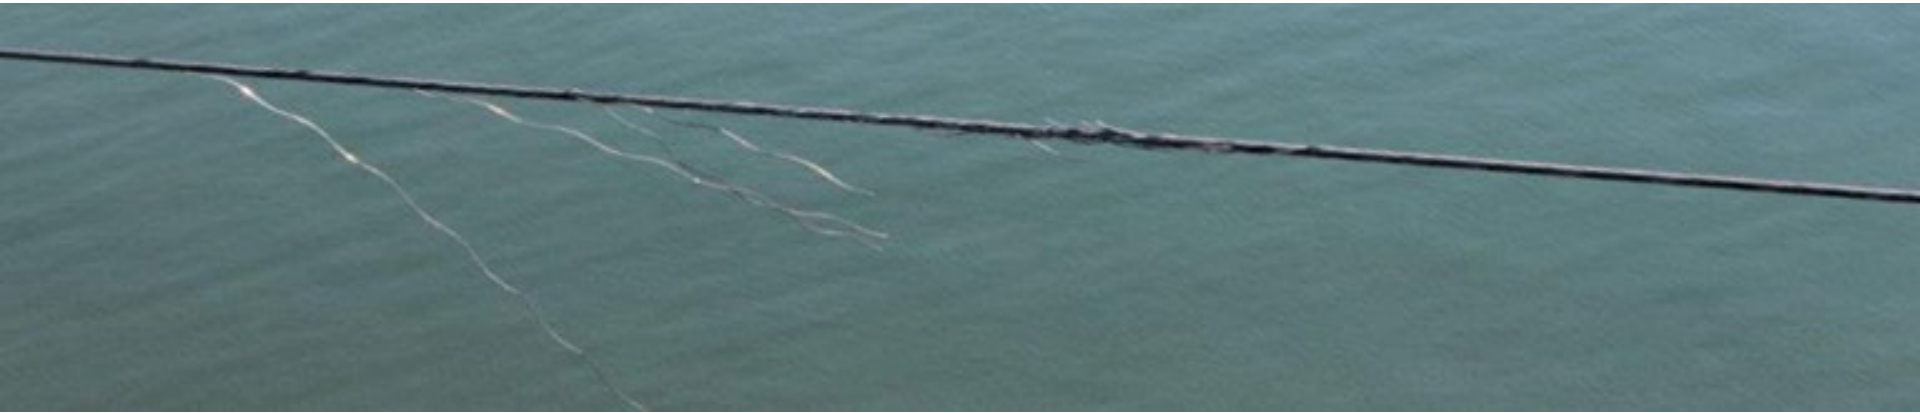
# Lightning Damage on Overhead Shield Wire and OPGW – Major expense!

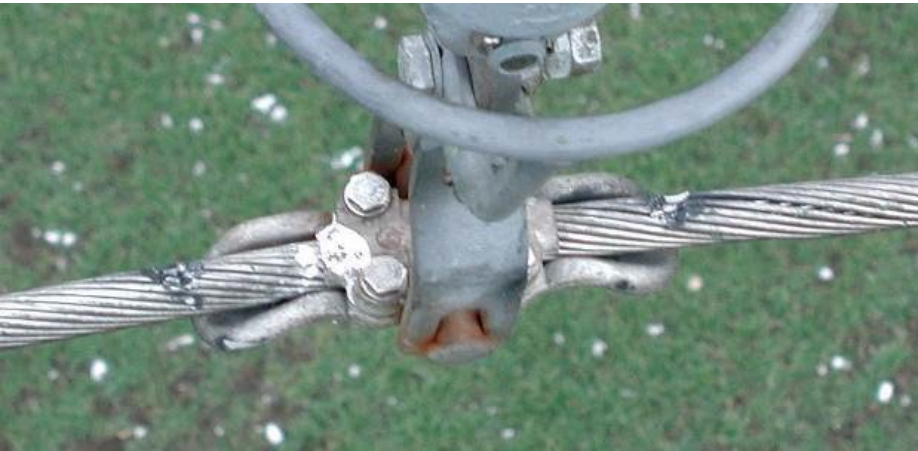
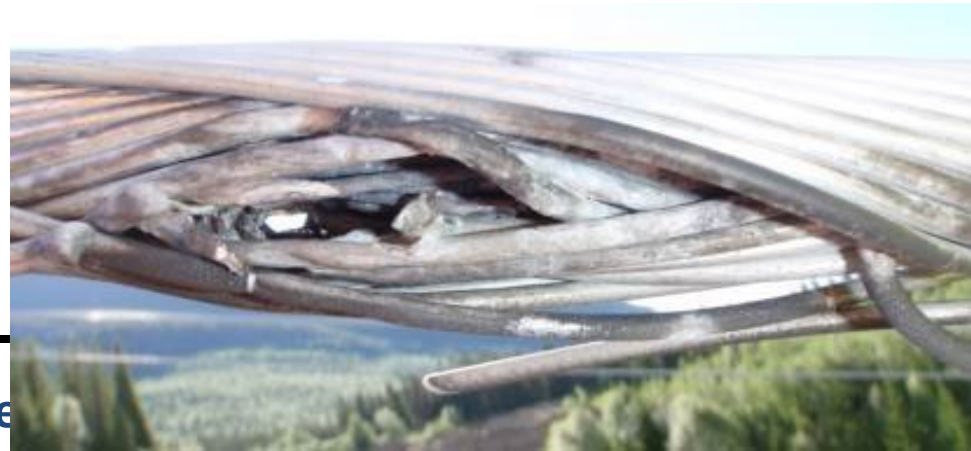
## Lightning Flashover Damage on Circuit Conductors Adjacent Suspension Clamps

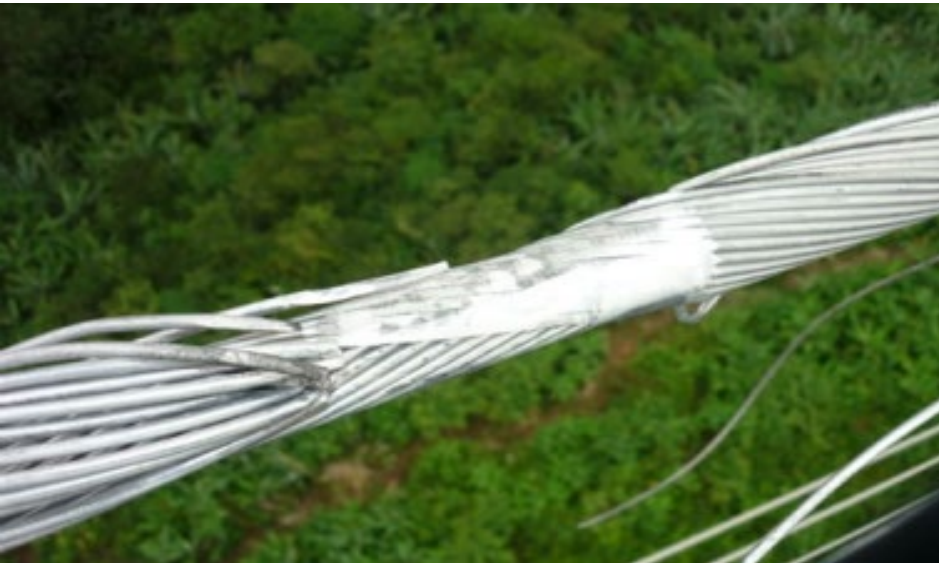
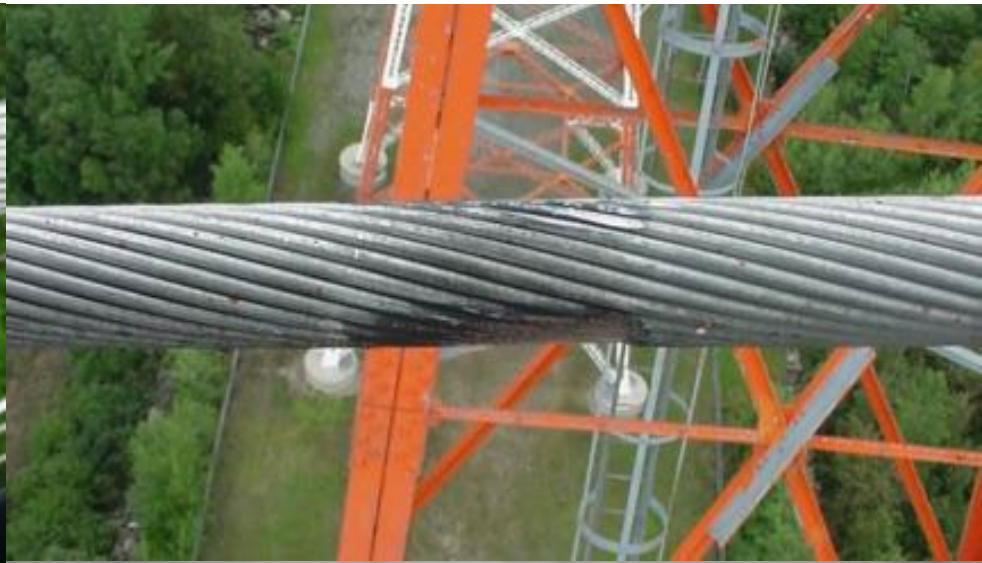
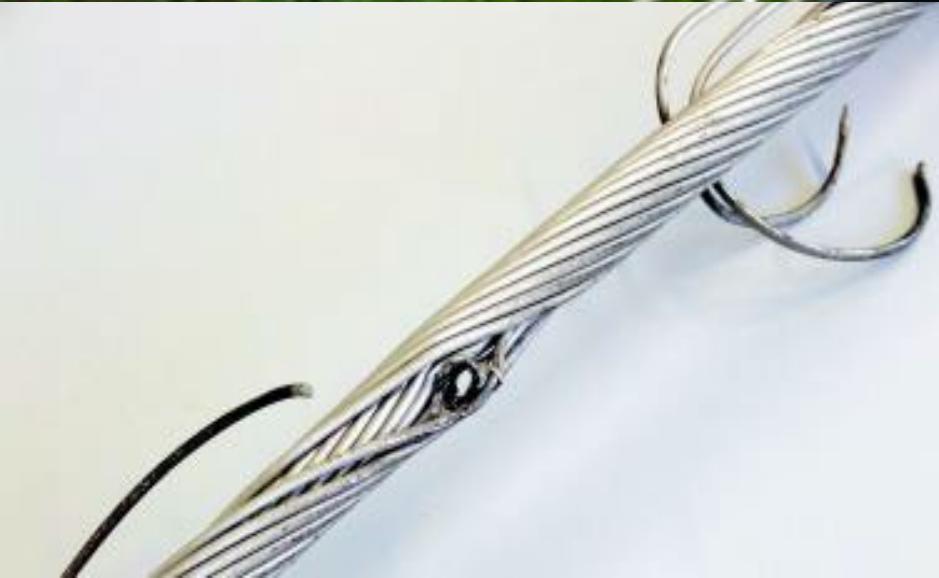
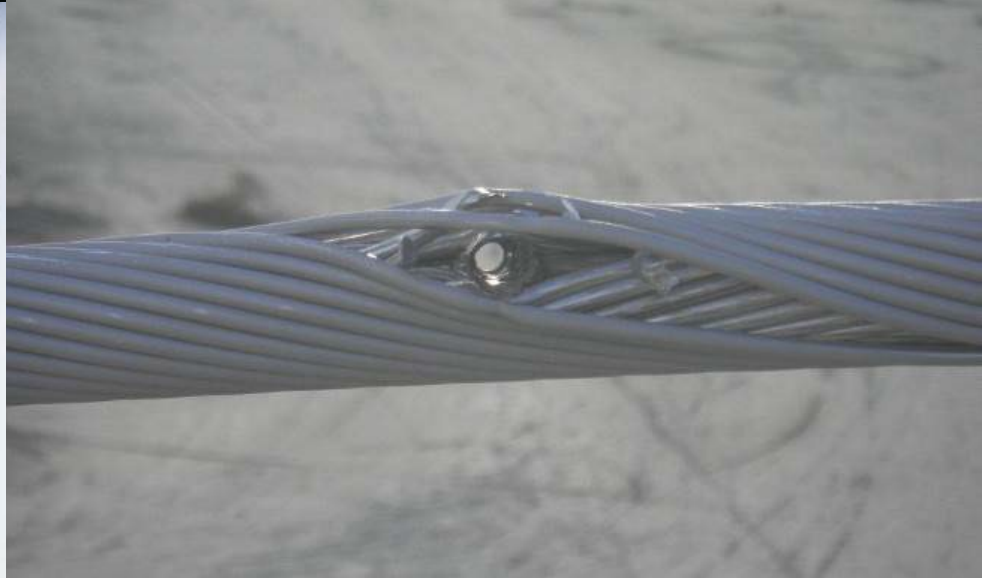
# Abraded Conductor & Gunshot Wounds

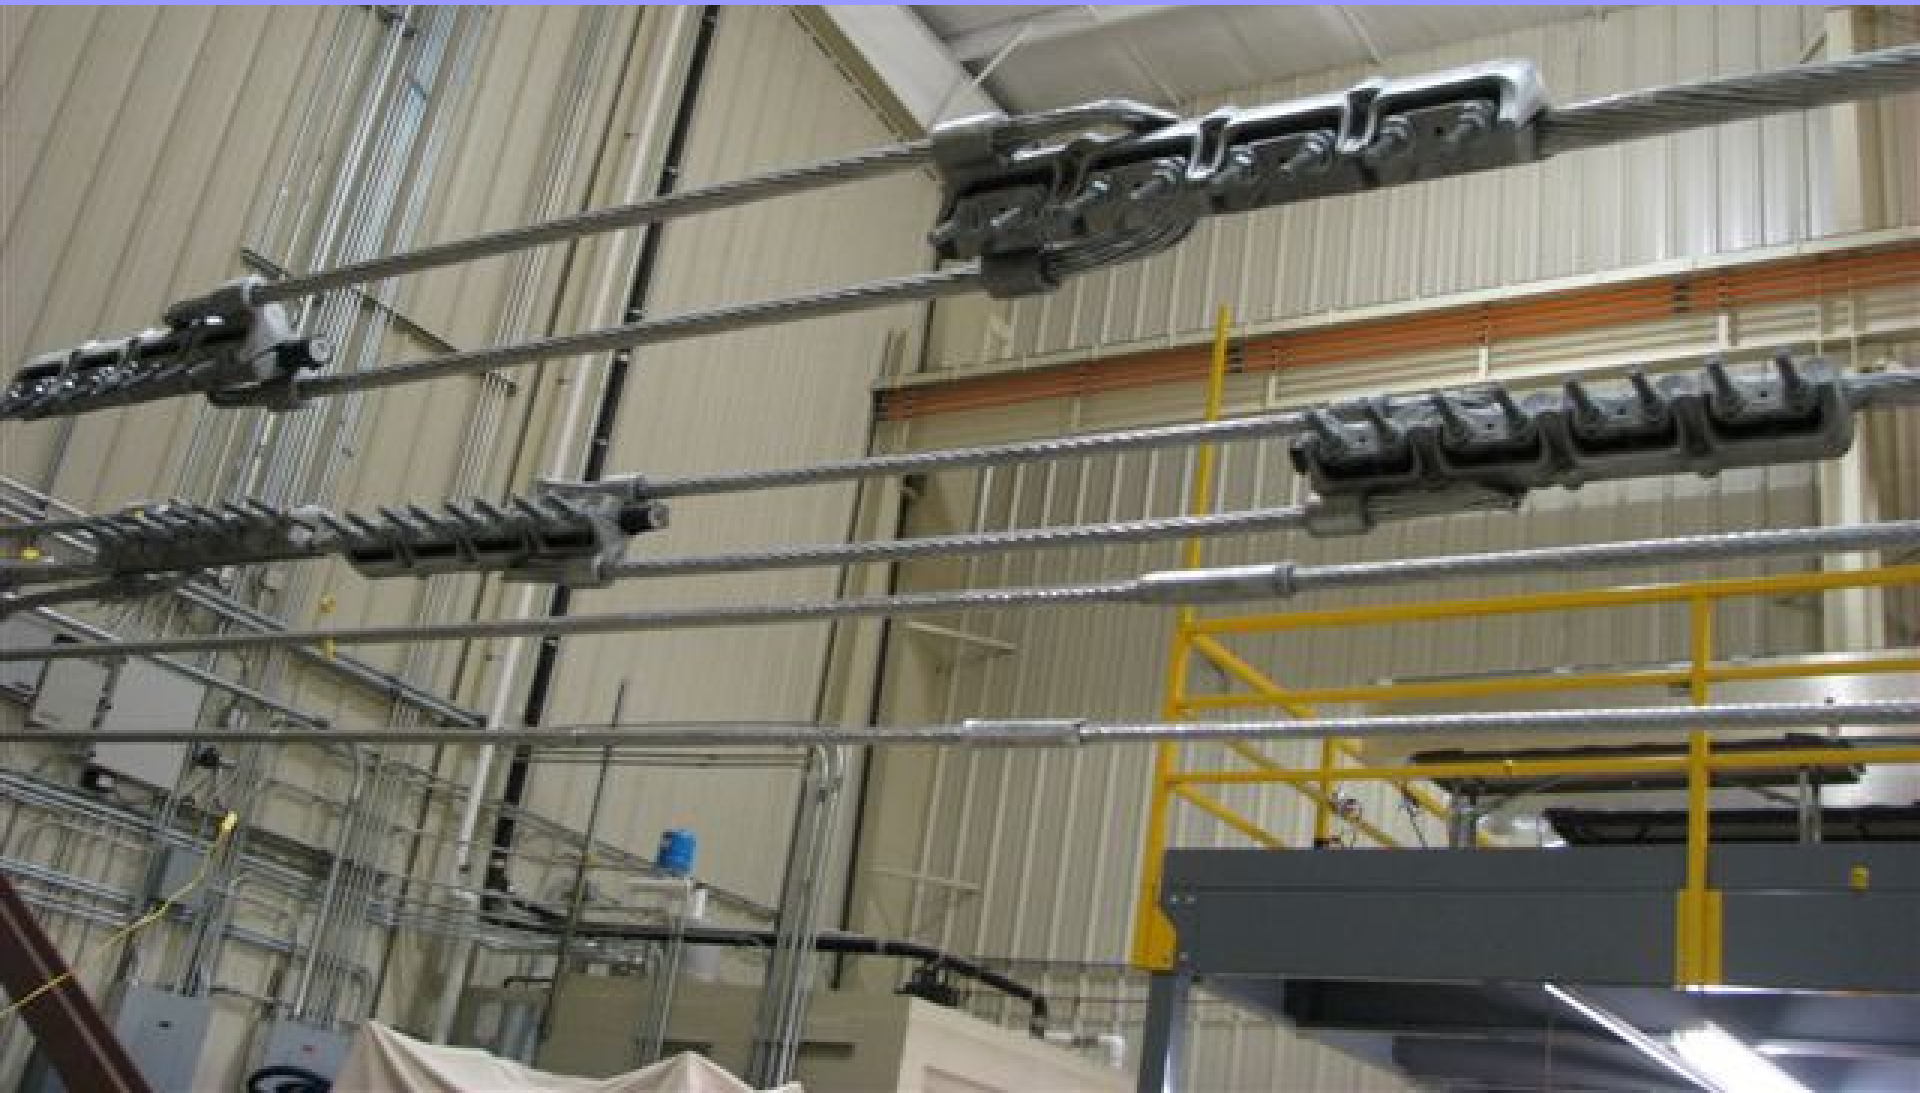
2000 Thermal Cycles with conductor at 35.6 kN (8000 lbs) tension, and  
conductor temperature of 200°C No connector in between –

Electrical/Mechanical Shunts serving full electrical and mechanical load.

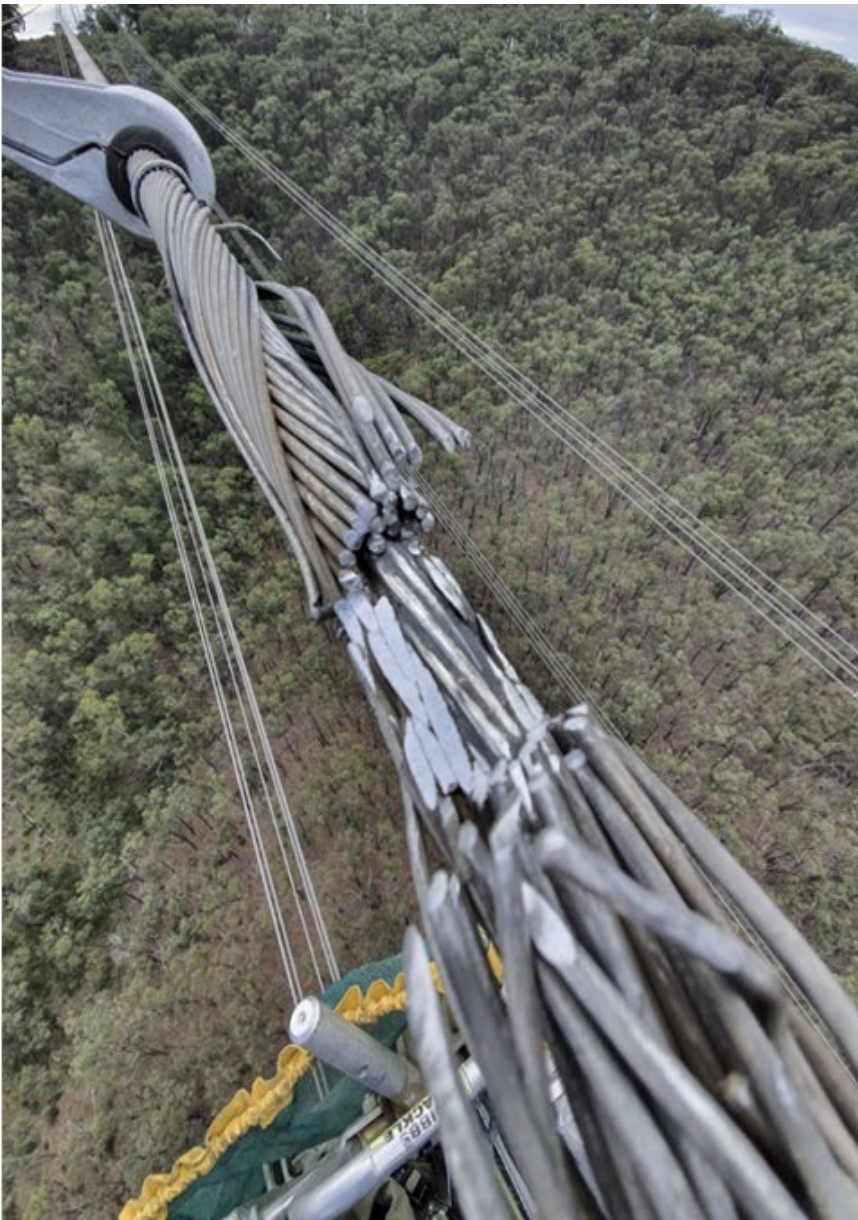
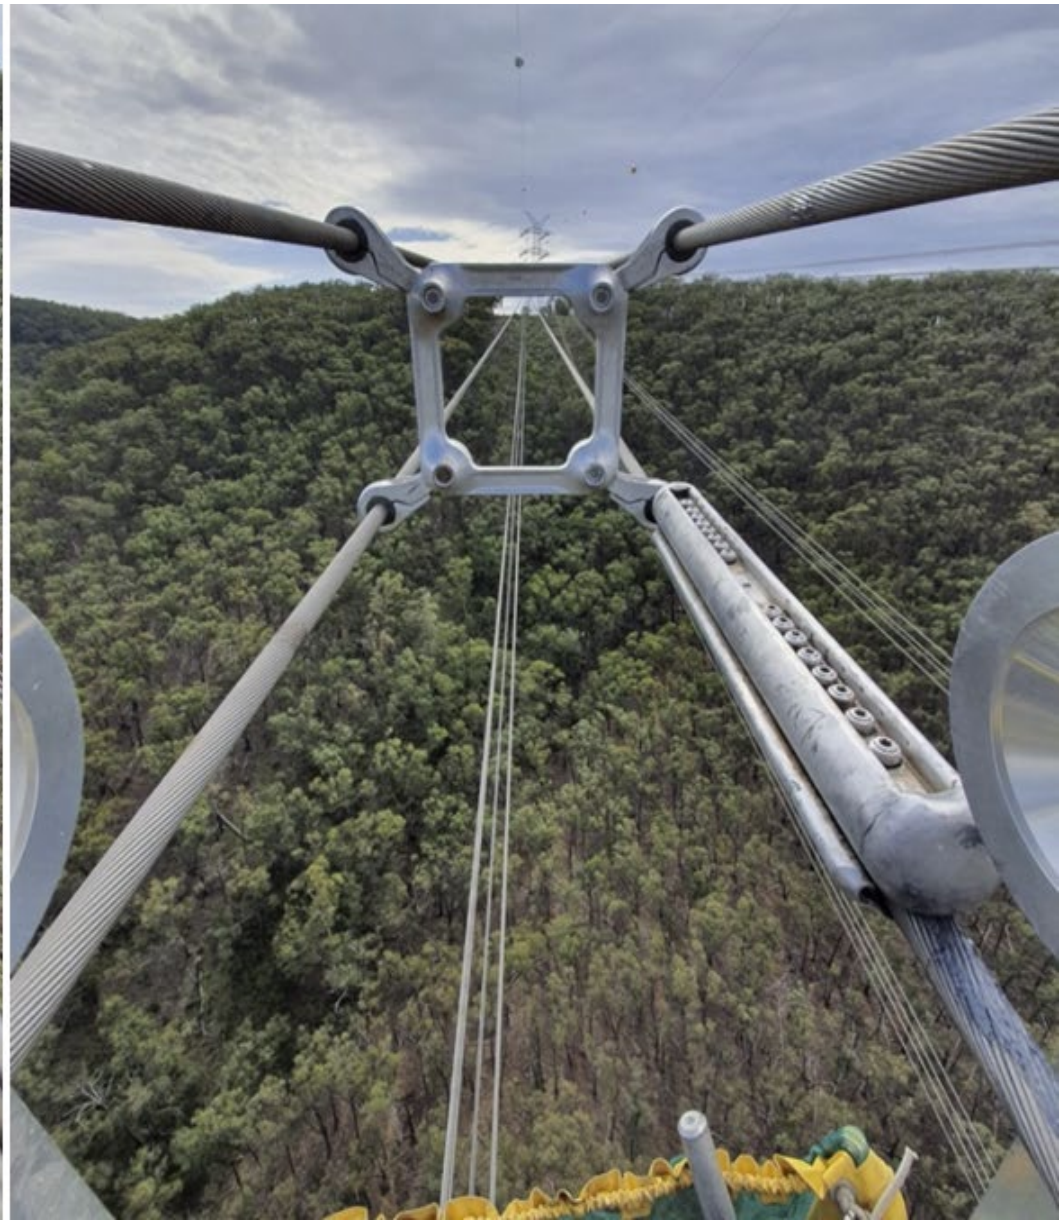
# ClampStar CRU – Before and After EHV

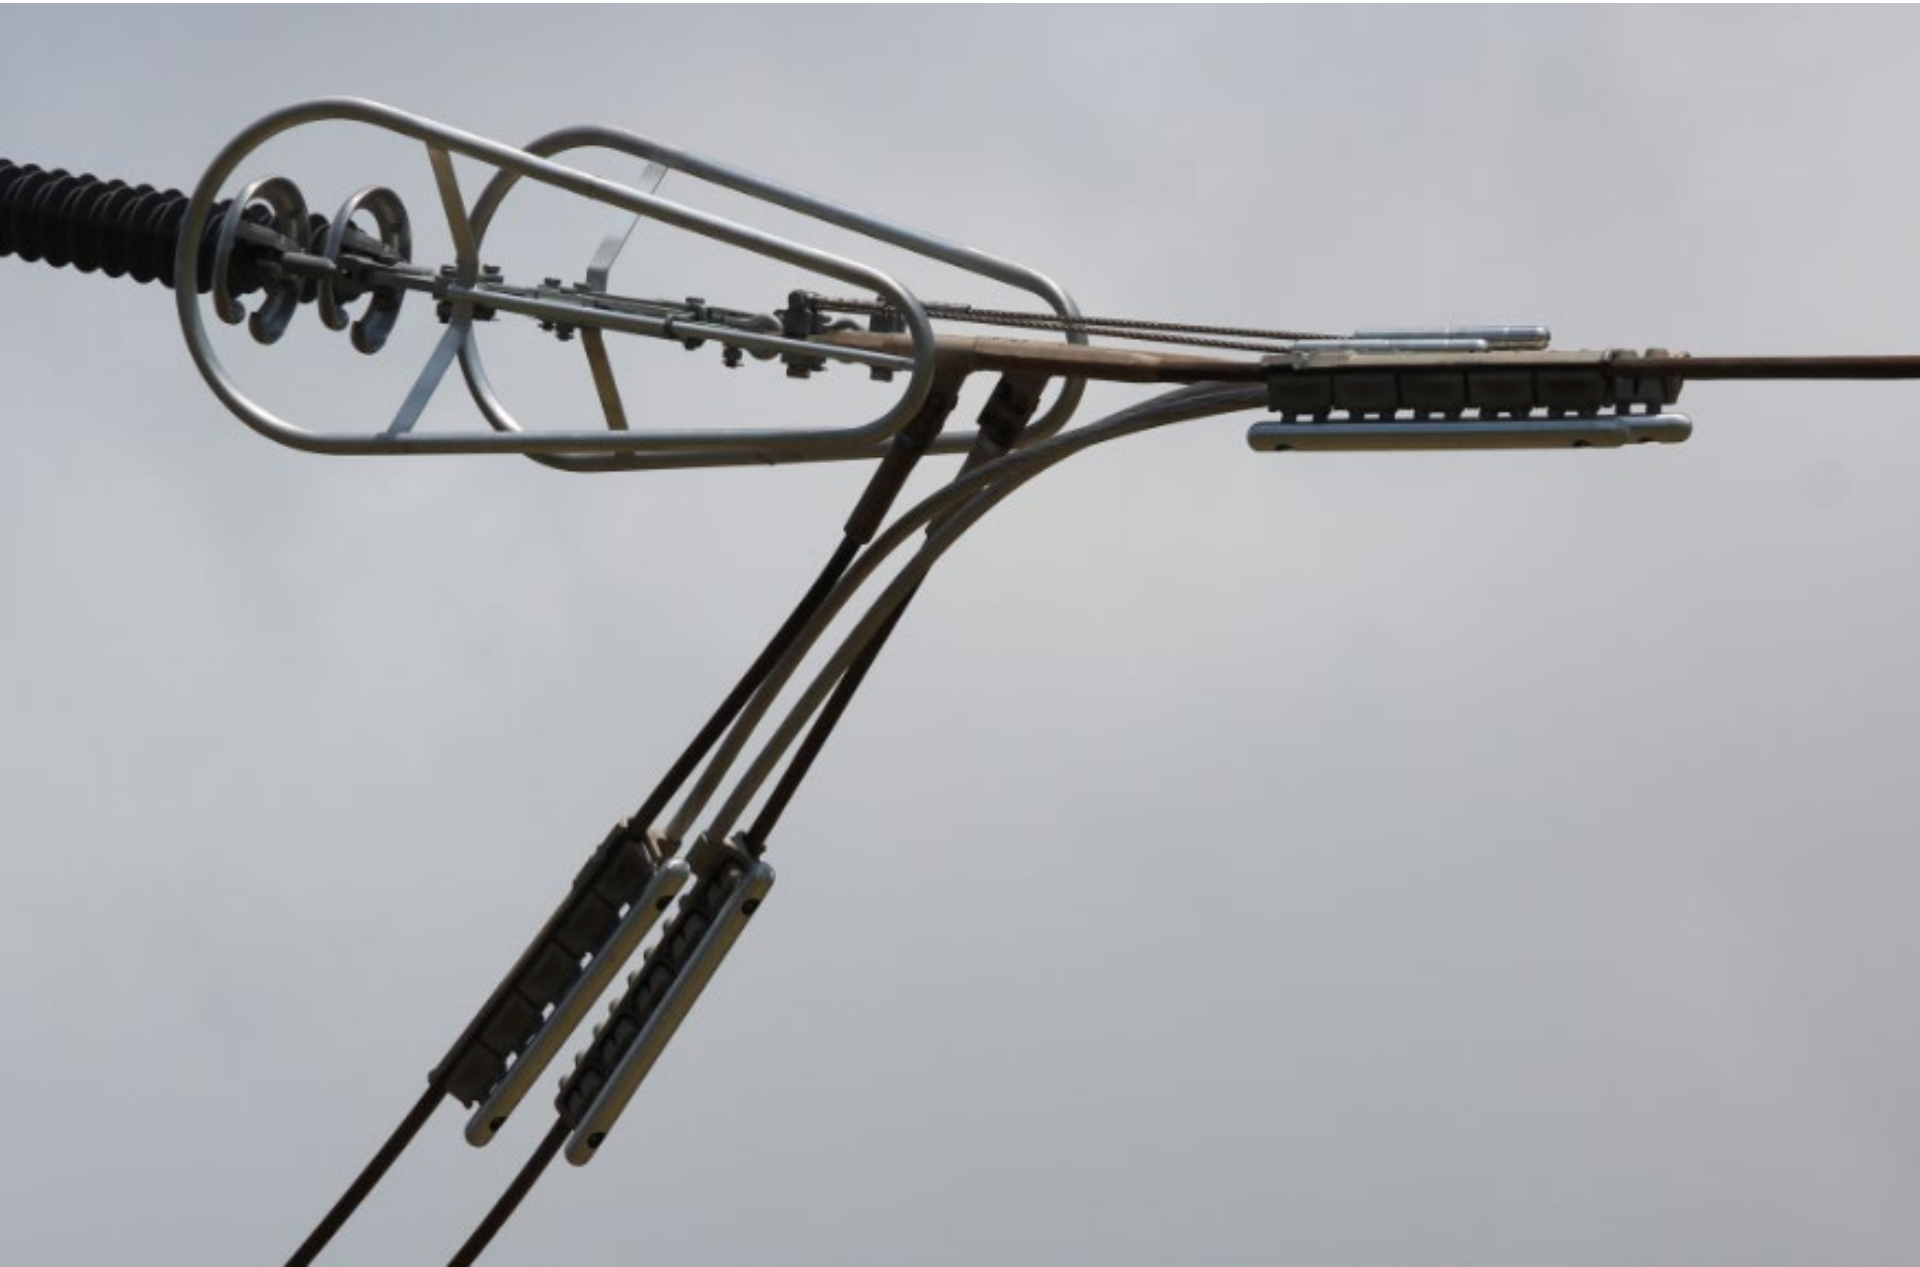
# Twin Bundle Deadend with Safe-T-Link Tethers - Australia

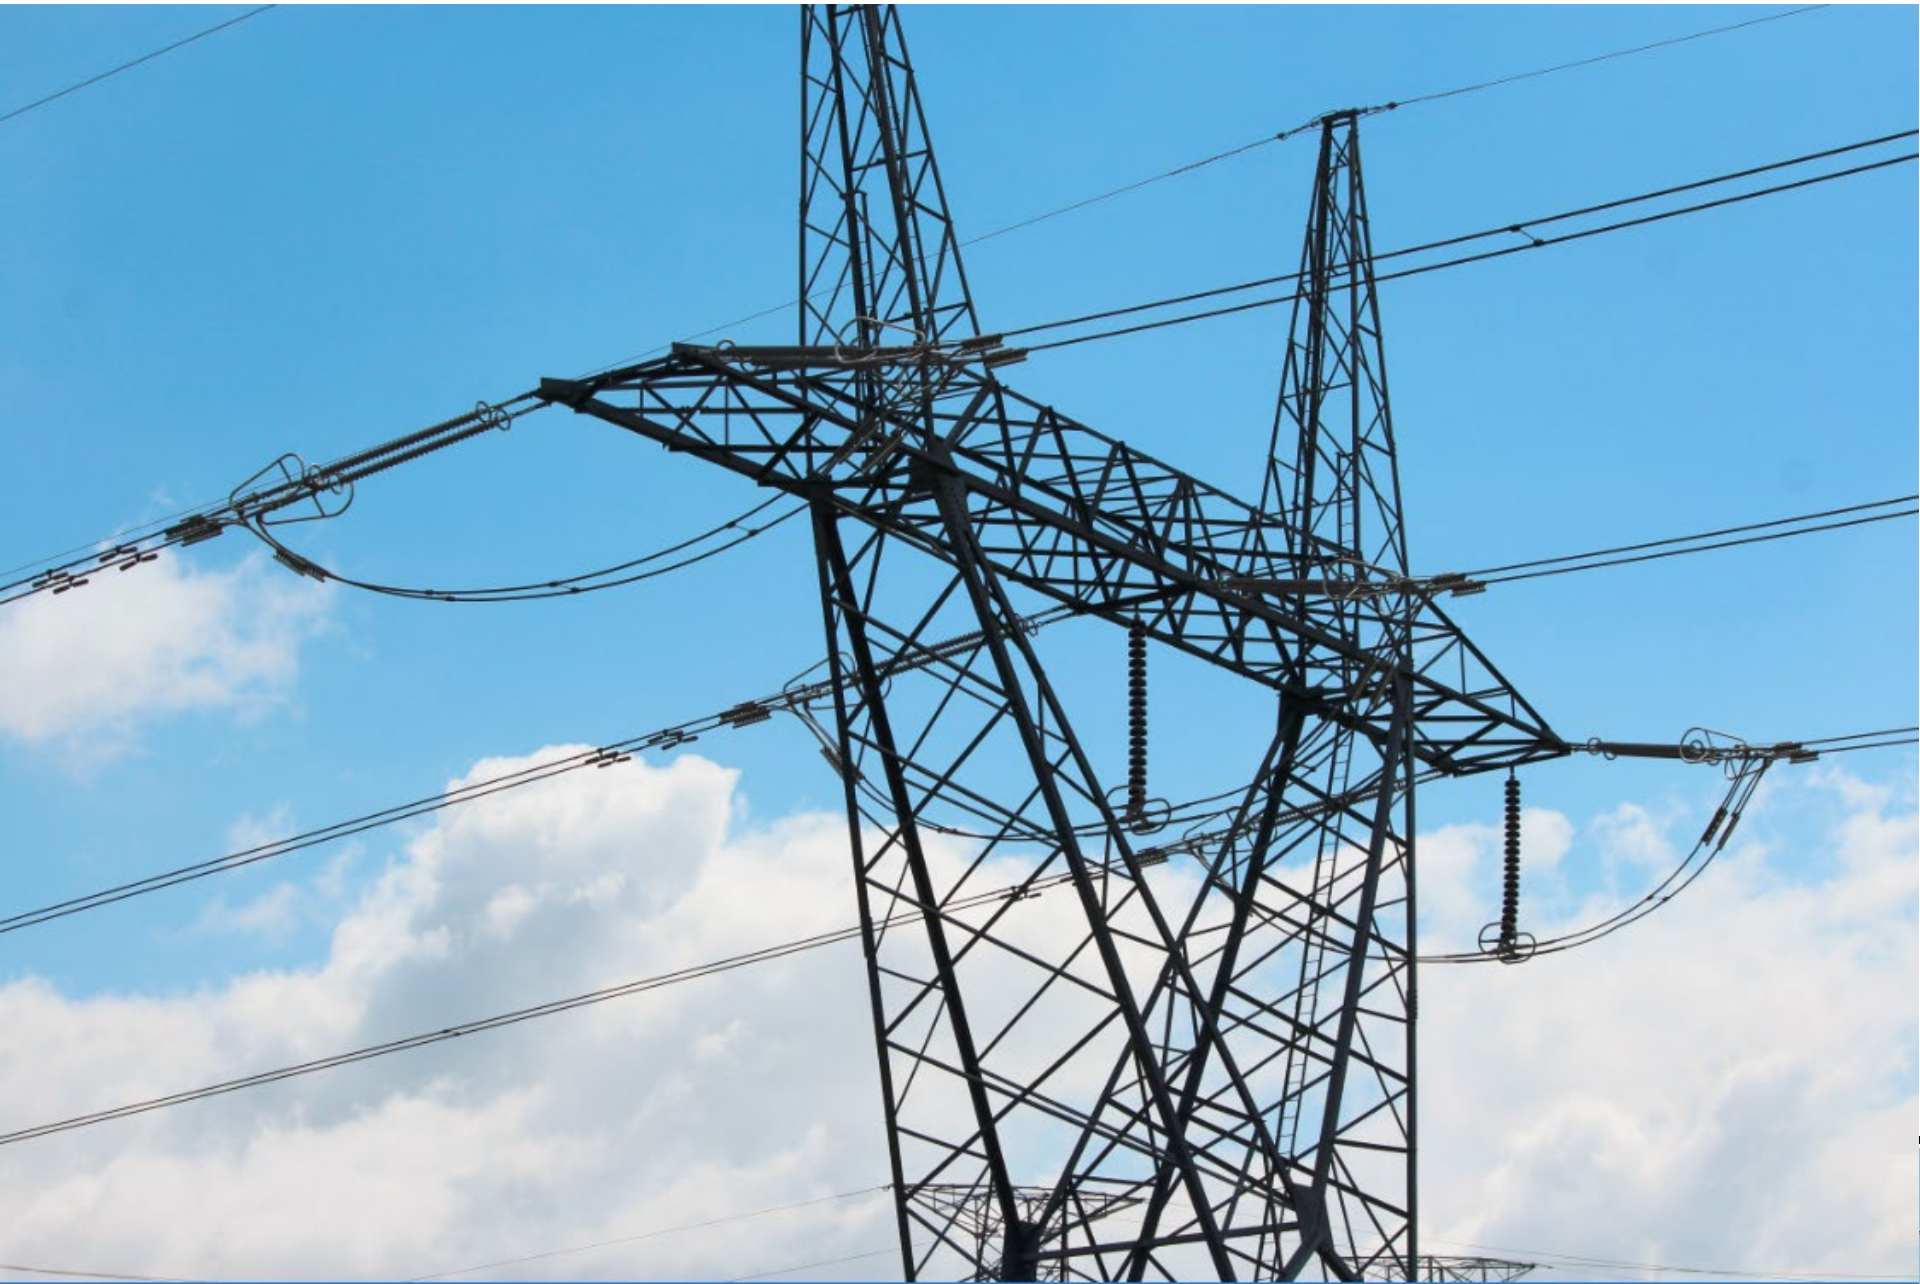
# CSS-1302 Twin Bundle Deadend 330kV - Australia

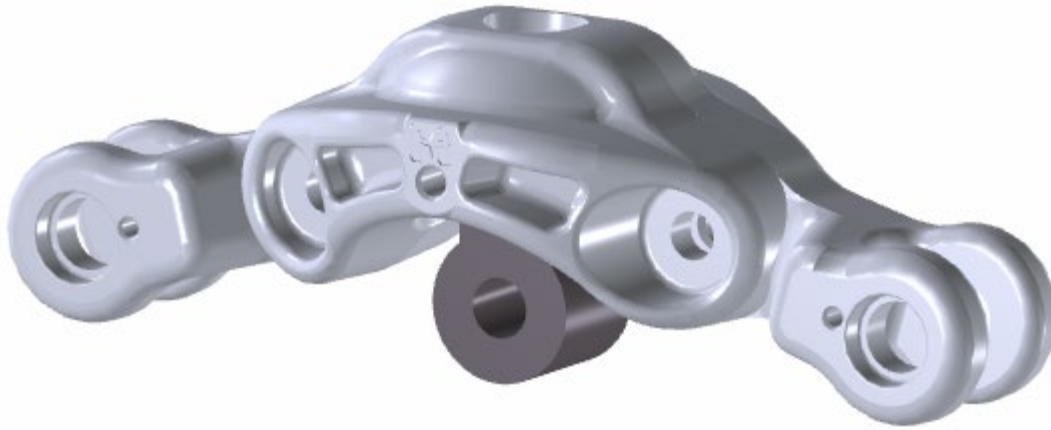
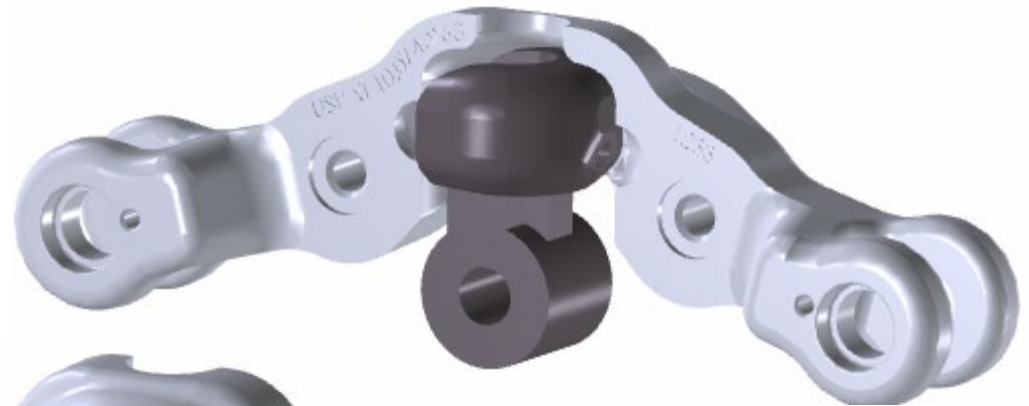
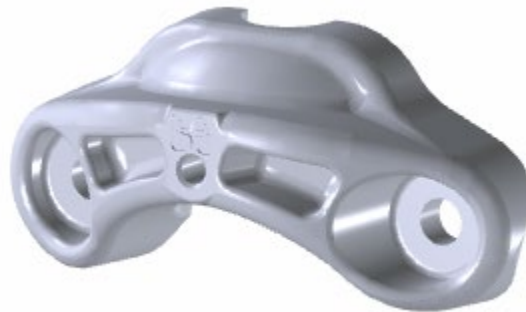
# EHV Ball Cap

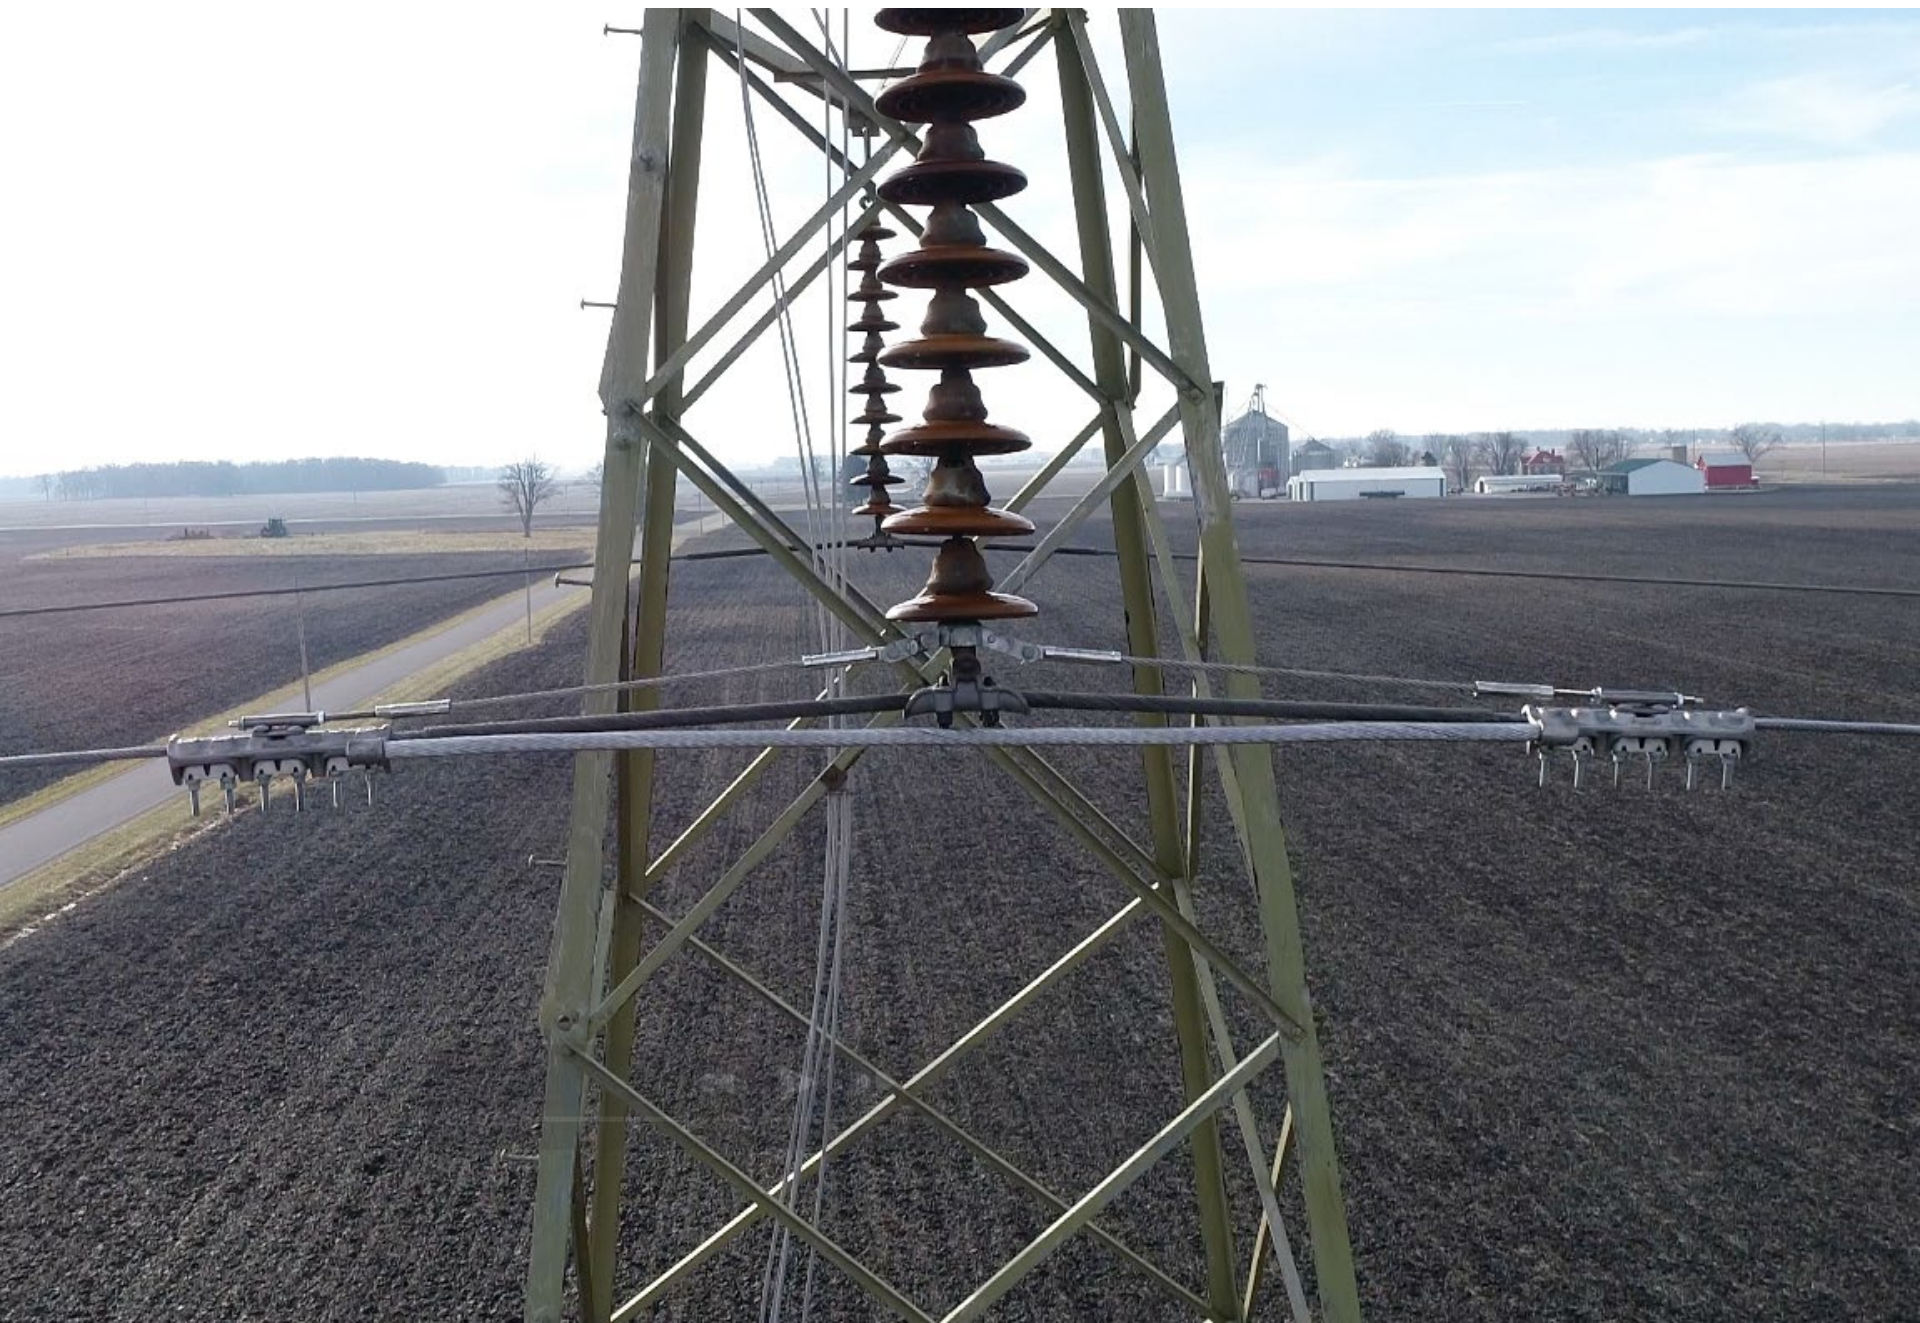
**Typical Ball Cap application, 477 Hawk with armor rods – broken strands under rods.**

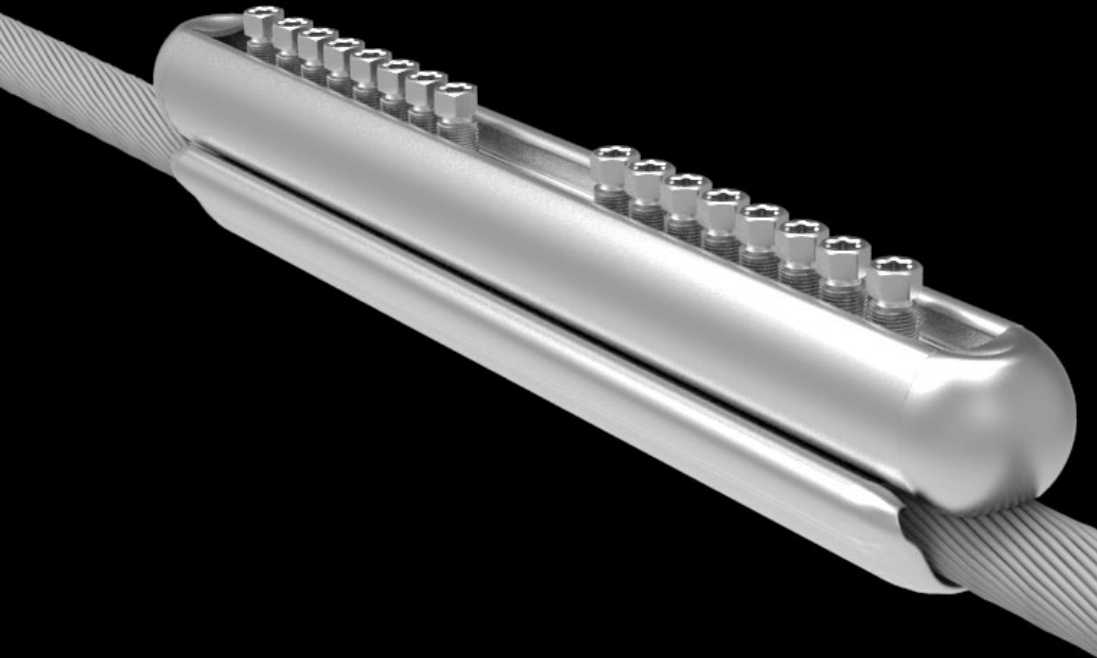
## Conductor Repair Units – OHSW Splice Correctors
