**CIGRE US National Committee  
2022 Grid of the Future Symposium**

**Extending the Life of Overhead Aging Assets  
with a  
Focus on the Energized Portion of Transmission  
and Distribution Lines**

**CARL R. TAMM  
Classic Connectors, Inc  
U.S.A.**

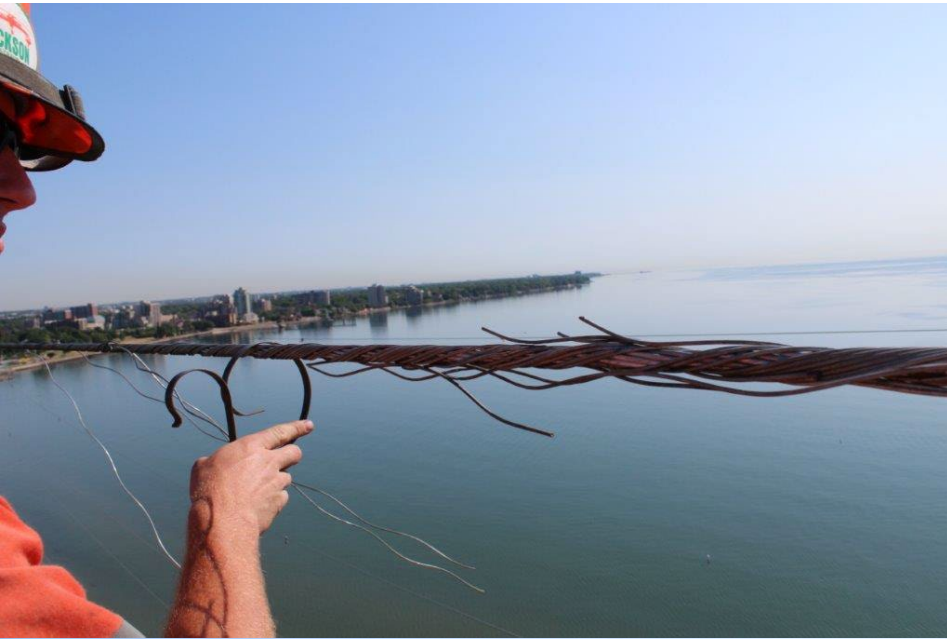
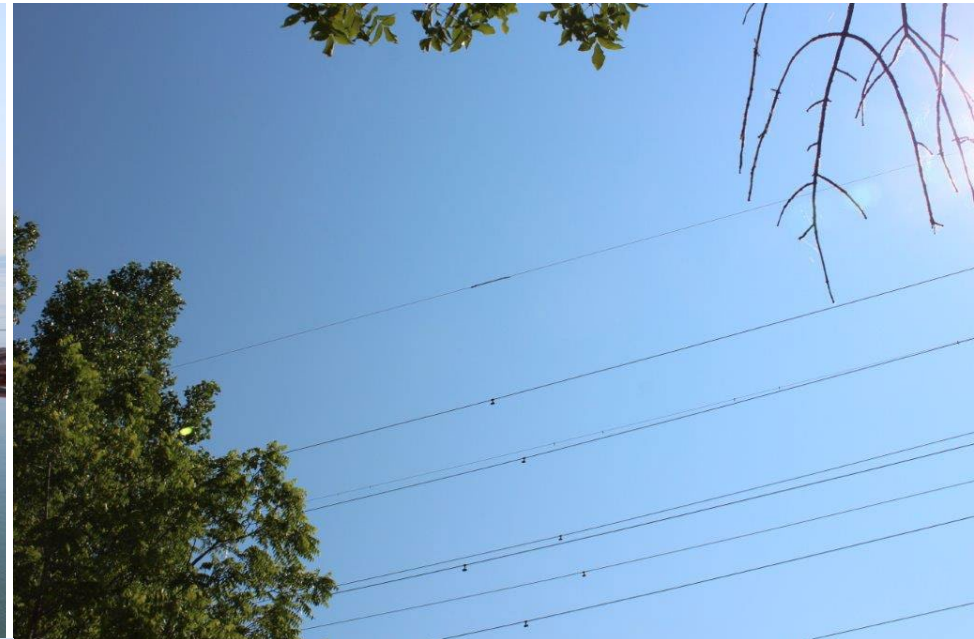
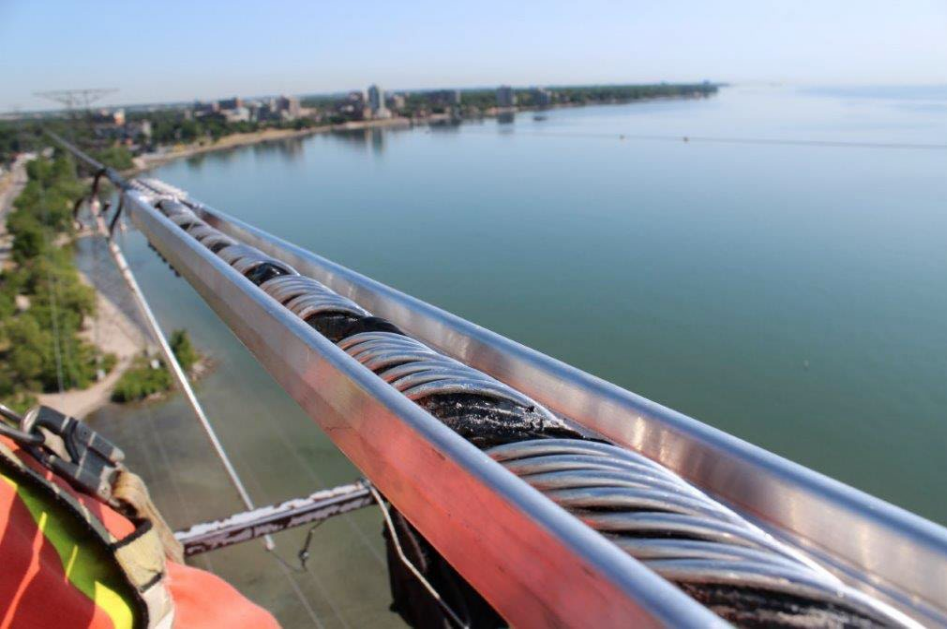
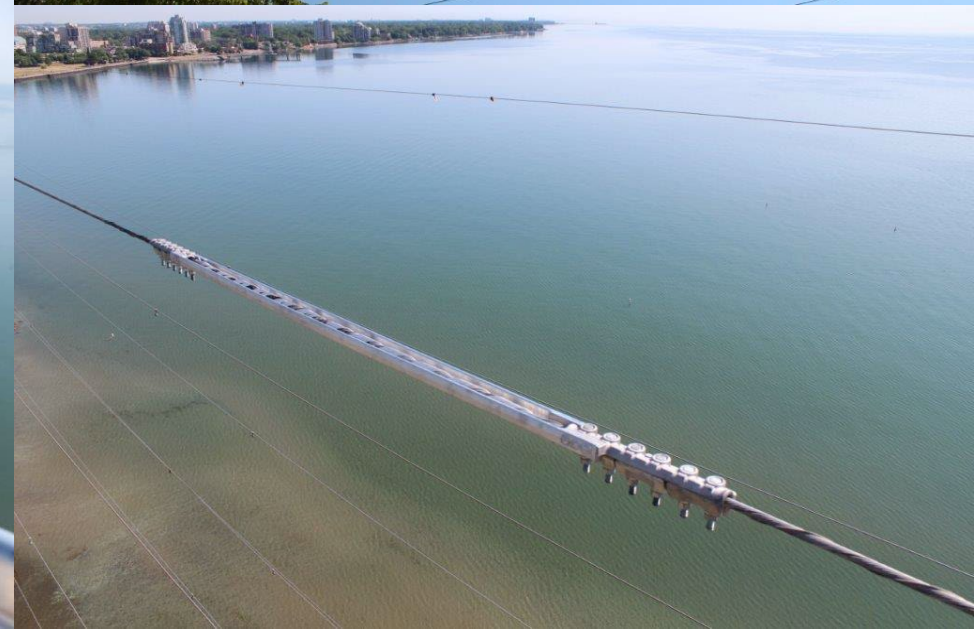
# OPGW Mid-Span Full Tension Repair

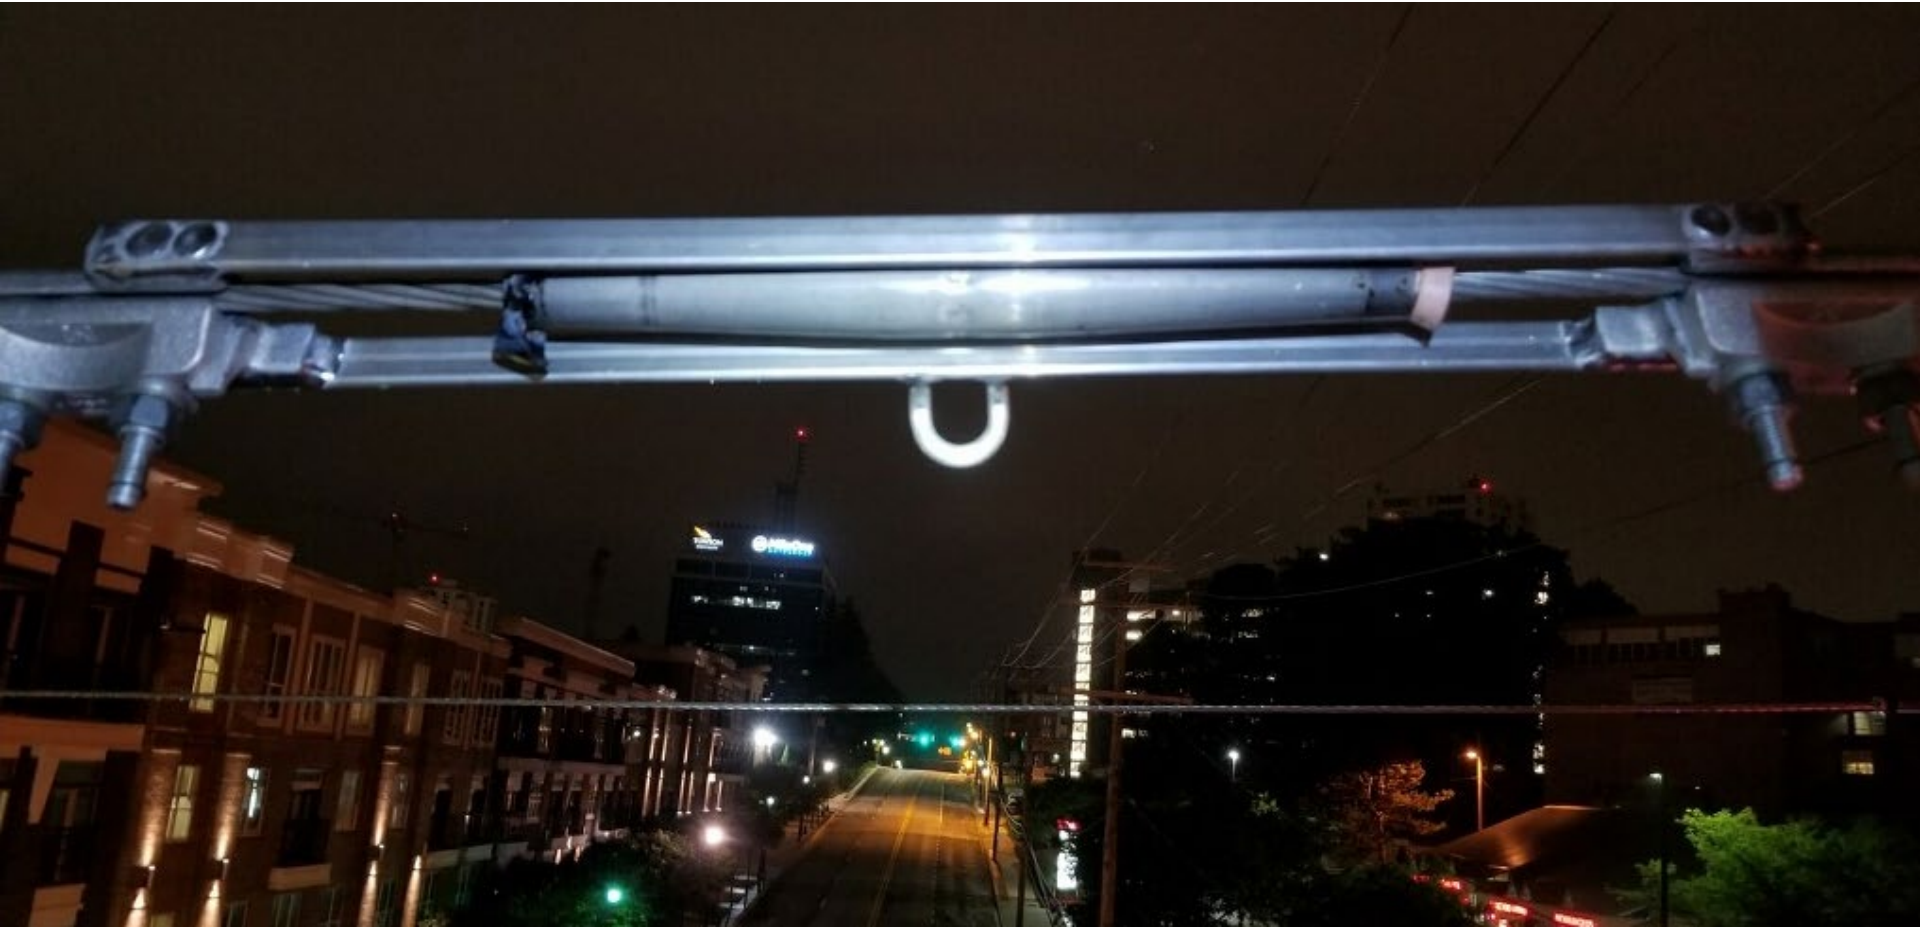
# A Properly Installed Automatic on a Distribution System – Caught in the Nick of Time!
