CIGRE US National Committee 2023 Grid of the Future Symposium

Condition Monitoring and AI in an Asset Management World

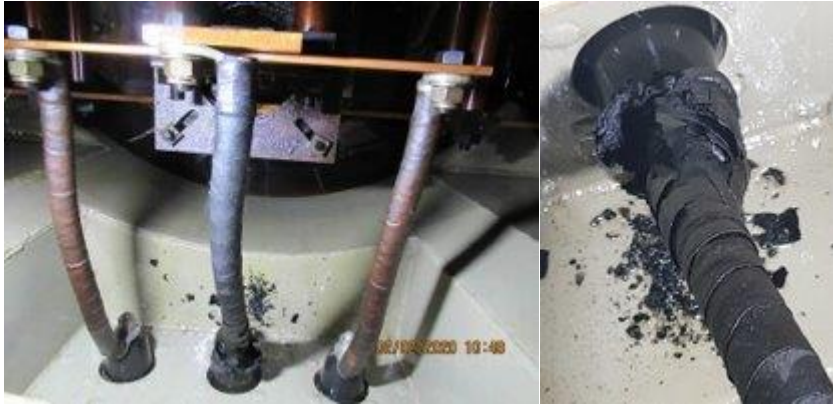
With this additional knowledge in hand, a subsequent internal inspection of the transformer was scheduled. Upon investigation inside the transformer tank, it was discovered that one internal connection was falling apart, causing arcing within the unit. The transformer was likely to fail catastrophically, possibly within hours considering the deterioration found.

Repairs to the connection were implemented, and the transformer was saved. Follow up actions from this discovery included checking sister units for a similar condition, which was confirmed and fixed.

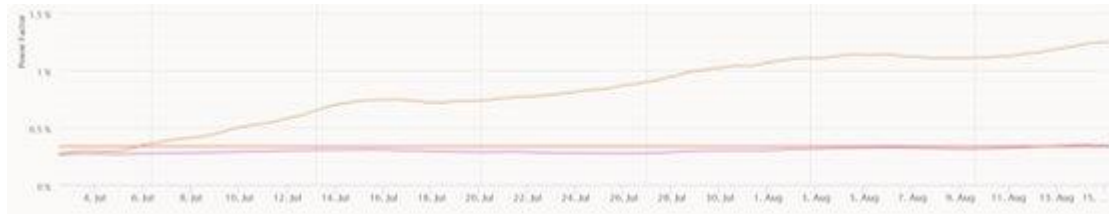
insulation system is deteriorating, and depending on the failure mode and type of bushing, we may have upwards of a few months time to locate a replacement bushing, and plan the outage. It appeared that this bushing was failing in the 'graceful' deterioration method, so it was decided to leave the bushing in service, and keep an eye on it. Over a period of several weeks, the figure below shows that increase in power factor, when compared to the other two bushings.
