CIGRE US National Committee 2016 Grid of the Future Symposium

Transformer Saturation Due to Transmission Line Induction

**S. SANKAR
S. SRINIVASAN
Black & Veatch
USA**

**J. PELON
ITC Holdings Corp.
USA**

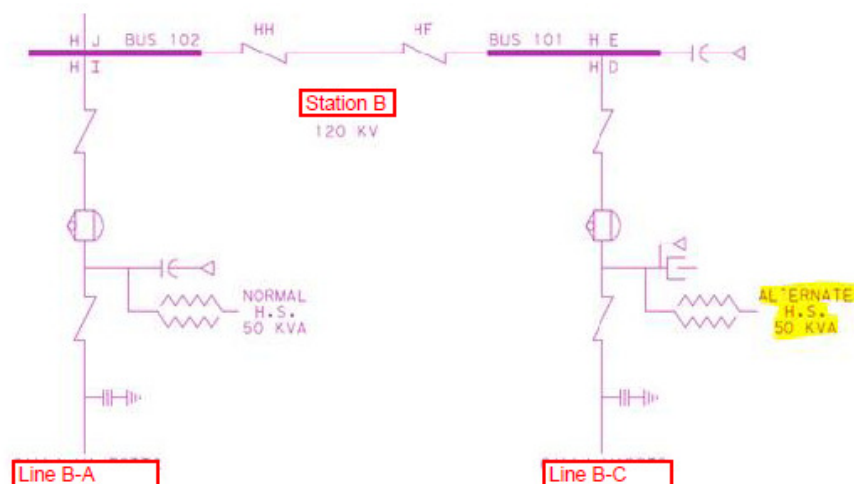
Figure 1: One Line Diagram of 120 kV Substation

ITC Holdings experienced two station service transformer failures at the same position on successive days in June 2015. The failures occurred at a 120 kV substation, shown in Figure 1. The transformers were single phase transformers rated 69 kV / 126.5 V, 50 kVA.

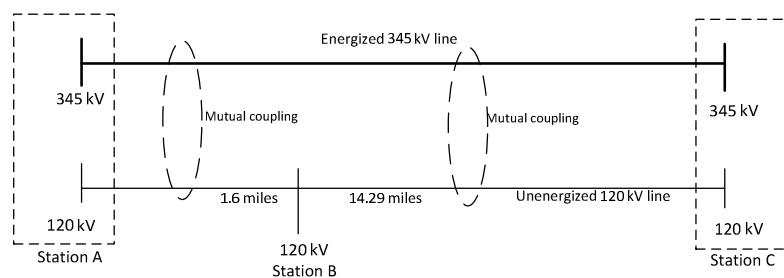
Figure 2: Transmission Line Configuration

Station B 120 kV is situated in between Station A and Station C and there is also a 345 kV transmission line between Station A and Station C. The 120 kV and 345 kV lines run on the same tower. A schematic diagram of their arrangement is shown in Figure 2.

Multi-circuit right-of-ways, similar to the B-C line, containing one un-energized circuit in parallel to an energized circuit, experience the effect of induced voltage on the un-energized circuit. This parallel induction is due to the capacitive coupling between the two circuits [4]. The induced voltage due to capacitive coupling also depends on the length of the line as well as the tower configuration of the overhead conductors.
