CIGRE US National Committee 2022 Grid of the Future Symposium

Improving Customer Power Quality Leveraging AMI Data

**G. KANDAPERUMAL, M. GUIEB, J. THEODOROPOULOS, M. RAVE,
C. DESJARDINE
Commonwealth Edison Company
USA**

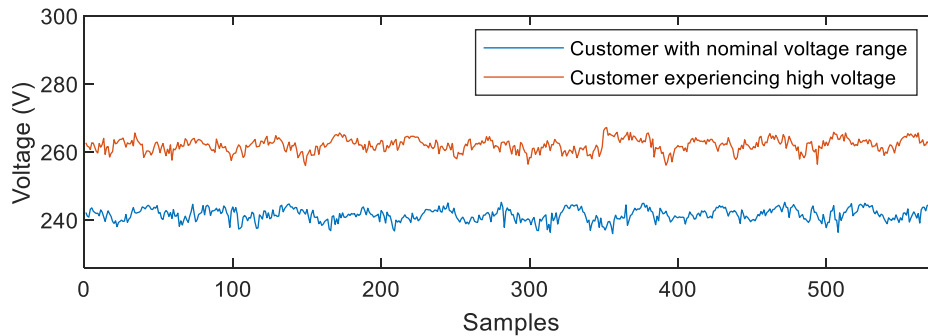
Figure 2. Voltage plots of customers with nominal and high voltage readings at the meter

Typically, the first step in identifying the cause of the voltage issue lies in the determination of the source of the voltage abnormality. The causes of the voltage issues can usually be distinguished by the number of customers affected in the feeder. The greater the extent of the voltage issues, the larger the number of customer calls registering a voltage complaint. If most of the customers in a particular feeder experience abnormal voltage values, the issue is usually at the head of the feeder – in the distribution substation due to incorrect substation bus voltage. In some instances, a misoperating distribution voltage regulator or capacitor bank can produce abnormal voltages at all customers downstream of the equipment, albeit for customers, an issue may be exacerbated by the length of the feeder section, and therefore voltage drop across the section.

However, if the voltage issue is localized at a single transformer as seen in Fig. 2(b), there are two possible causes – Transformer in incorrect primary tap setting, or the transformer has an internal fault in the primary winding, effectively increasing the turns ratio and expressing a higher than nominal secondary voltage.

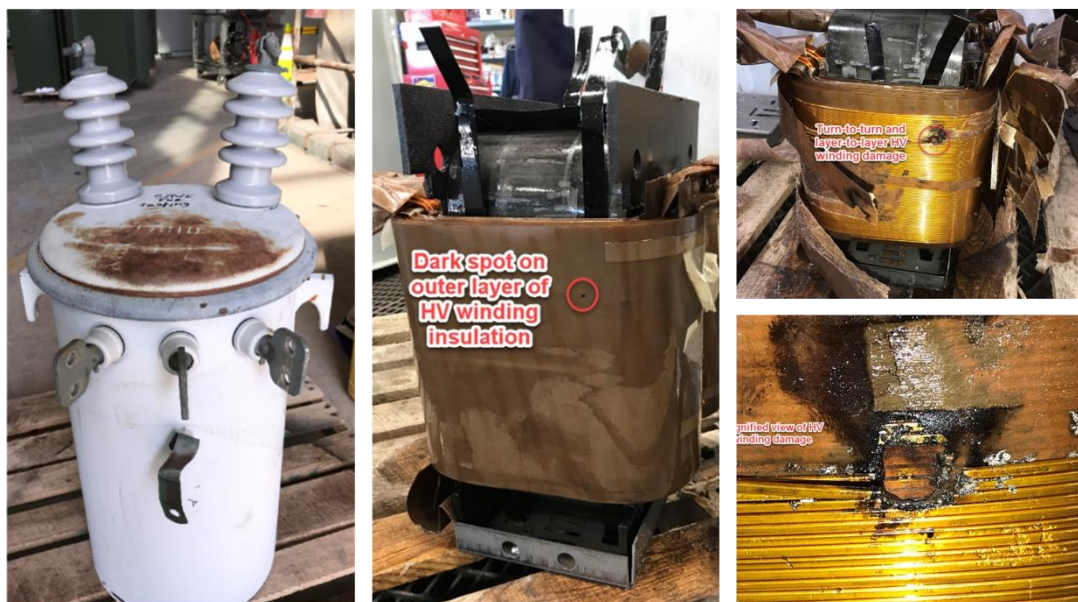
The core & coil assembly was removed from the tank and revealed obvious HV winding damage.

Figure 4. Images from forensic analysis of transformer failure. Starting from left going clockwise.

- 1) Exterior of failed transformer
- 2) Observed damage on exterior of insulation
- 3) View of the HV winding damage
- 4) Magnified view of HV winding damage
